Royal River Corridor Study Yarmouth, Maine Natural Resource Reconnaissance Surveys

July 2008

Introduction

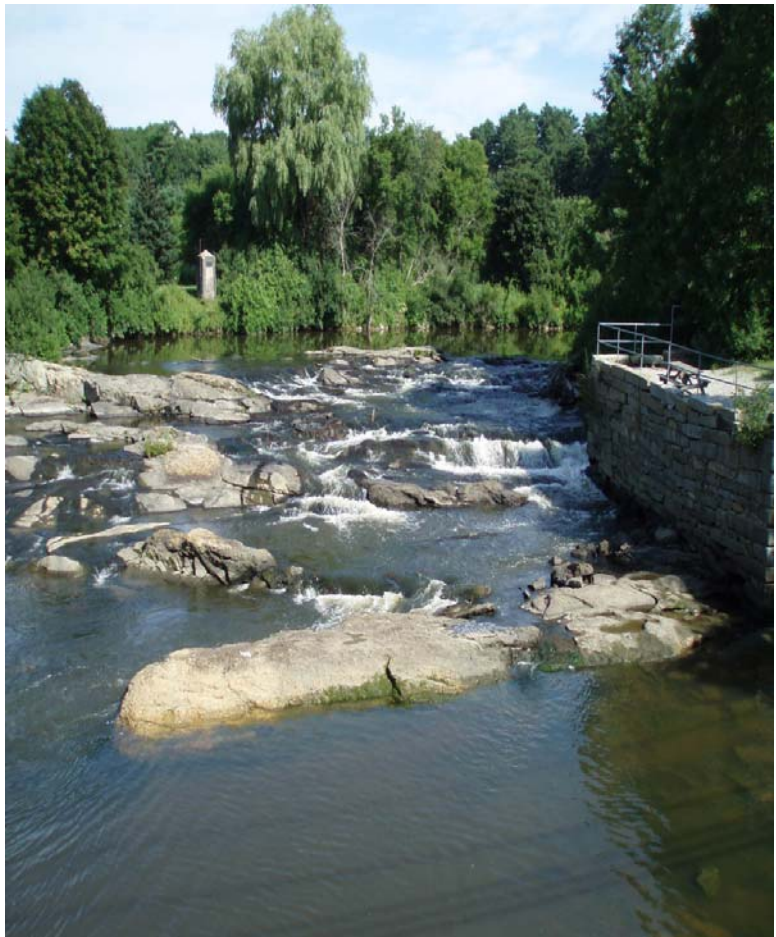
The “Lower Falls” exist at the head of tide near East Main Street, adjacent to Grist Mill Park. Upstream fish access is possible at higher tides at this location. The bedrock outcrops that comprise the falls include a series of stepped and offset ledges that are oriented nearly perpendicular to the river flow direction, which appear to provide a series of resting pools and natural ramps suitable for a variety of fish species to use for passage during appropriate flow regimes.

Photo 1-1. Lower Falls at East Main Street, consisting of a series of stepped ledge outcrops suitable for fish passage.

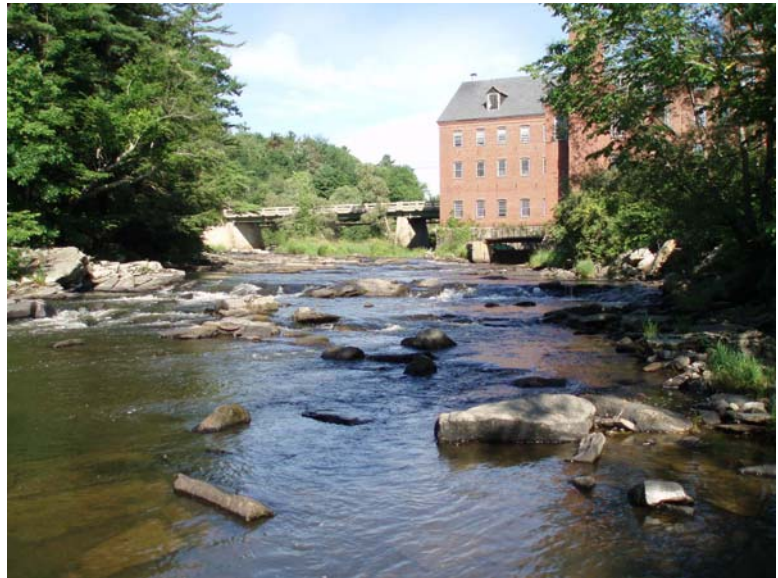
Between the Lower Falls and the Bridge Street dam, riverine habitat exists with various critical fish habitat types include riffles, runs, and pools. A variety of substrates are found in this section of the river, including fine silt and mud, fine sand and silt bars, gravel beds, and ledge. A series of offset ledge outcrops are found in the river immediately adjacent to the Sparhawk Mill and extending up to the Bridge Street dam, which result in a habitat and series of steps similar to that found within the Lower Falls.

Photo 1-2. River habitat between the Lower Falls and Sparhawk Mill includes riffles, runs, and pools.

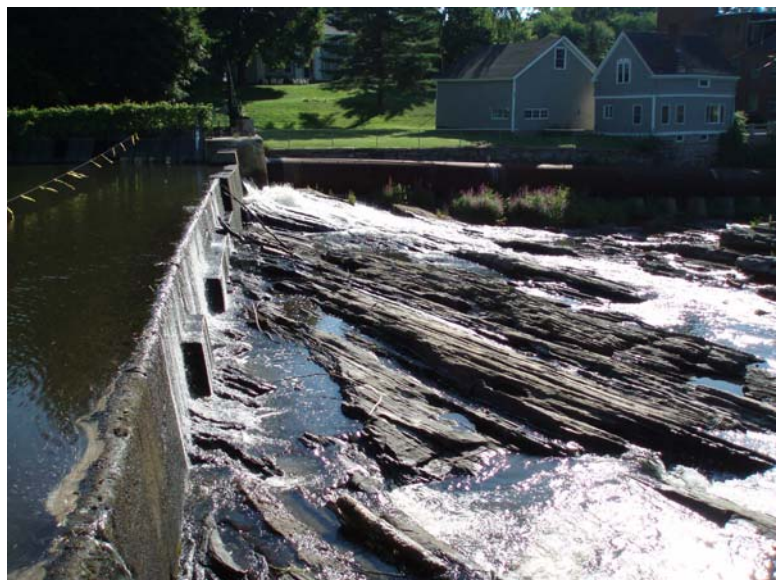
Photo 1-3. The Bridge Street dam was installed atop a series of stepped ledges, and serves as a complete barrier to fish passage.

The Bridge Street dam located just upriver from the Sparhawk Mill is a run-of-river concrete structure estimated to be four to six feet high, which was installed at the top of a series of ledge outcrops. The dam provides low-head water to the adjacent Sparhawk Mill through a metal penstock. The dam appears to serve as a barrier to all fish species. An old dock and woody debris are also blocking the outflow of this dam. Due to the similar structure and orientation of the bedrock in this section of river compared to Lower Falls, it is likely that fish passage through the falls at Bridge Street would be possible if the dam was removed.

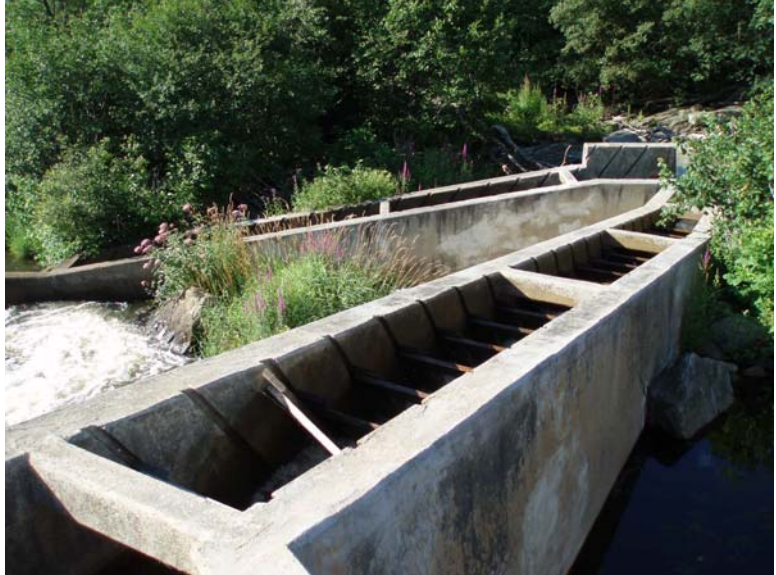
The Bridge Street dam has an existing concrete Denil fish passage on the south side of the river. The fish passage has some flaws apparent that need to be addressed, including several broken and missing boards. Regular maintenance is required of these types of fish passages. It is also unclear whether appropriate flows are able to be maintained in this structure during all fish migration periods during the year. In addition, it is uncertain whether the fish passage outlet's location or flow is appropriate to serve as a significant attractant to fish species moving upstream.

Photo 1-4. The Denil fish pass at the Bridge Street dam.

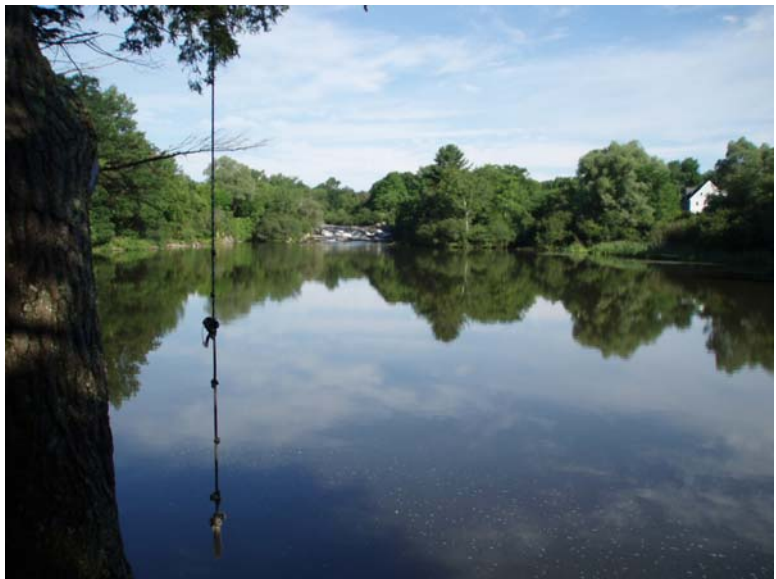
Between the Bridge Street dam and the Upper Falls, a lentic system exists within the impoundment. The depth of the impoundment is uncertain, but could be expected to be between three feet and ten feet deep based on the dam height and the visible bottom under the Route 1 bridge.

Photo 1-5. Above the Bridge Street dam, a quiet impoundment exists.

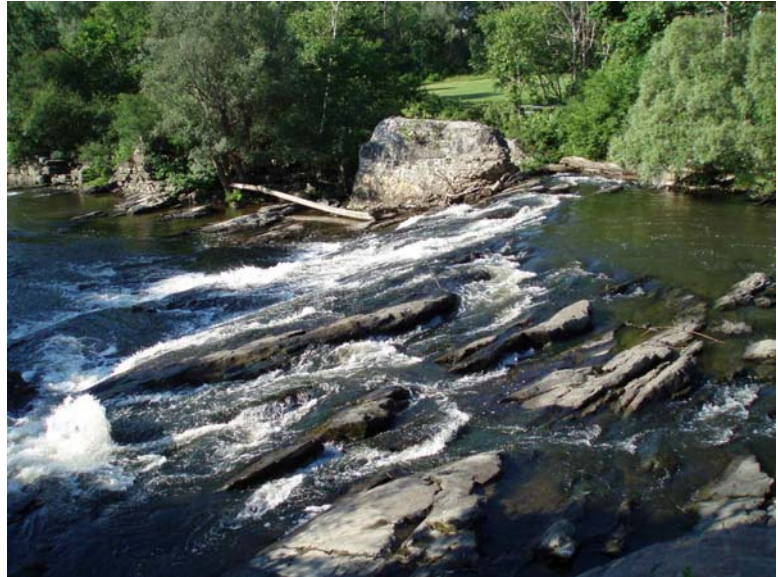
Upstream from the Bridge Street dam impoundment, a set of natural falls exist in the main channel, known as the Upper Falls. The Upper Falls consist of a series of stepped, offset ledge outcrops similar to those in the Lower Falls, as well as a series of riffles, runs, and pools between the ledge areas.

The geometry of the Upper Falls may prevent upstream fish passage under most flow conditions. A natural channel exists around the falls to the east, however, which will allow successful upstream movement of a variety of fish species under proper water flows.

Photo 1-6. The Upper Falls, adjacent to Royal River Park.

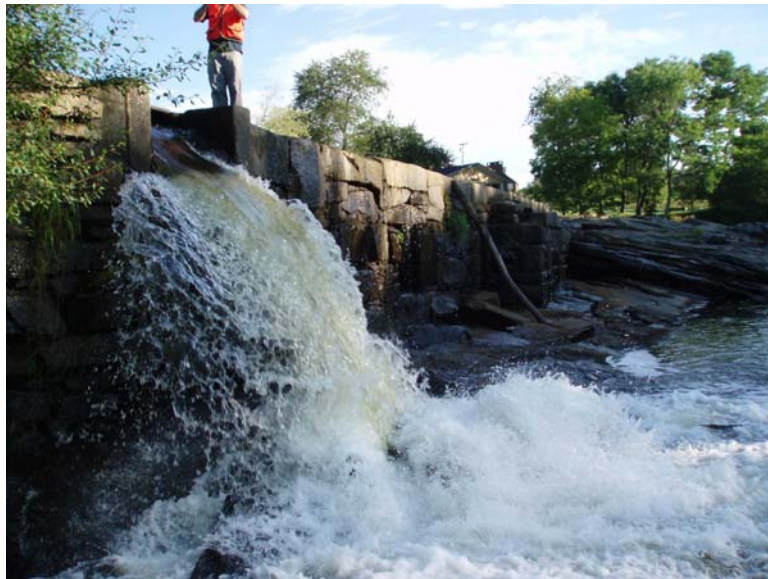
The upstream-most dam at East Elm Street is a masonry dam estimated to be four to seven feet high built atop ledge outcrops. The dam is very porous with visible leaks observed and spillover occurrences, including leaks at a sluiceway gate with wood panels located at the south end of the dam adjacent to the spillway. The dam is a complete barrier to upstream fish movement. Downstream fish movement is also of concern at the East Elm Street dam. Fish following downstream currents may become impinged in dam holes where water is leaking.

Photo 1-7. The East Elm Street dam, with leaks visible between stones.

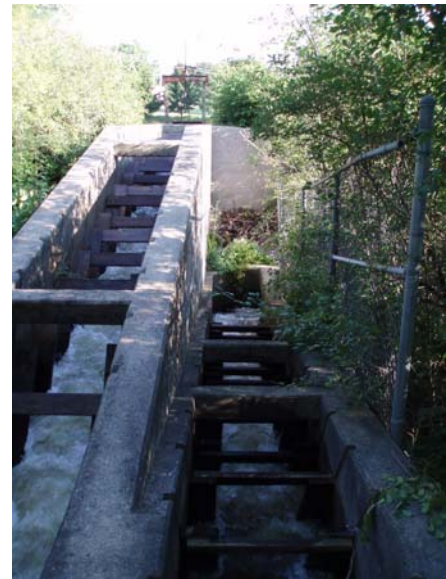
An existing concrete Denil fish passage at the south side of the dam has flaws which require maintenance. As with the Bridge Street fish pass, several of the wooden vanes were damaged or missing, and both the fish passage and dam have large woody debris entrained. In addition, it is unclear whether the Denil outlet location and flows are suitable to attract fish. A natural side channel of the River exists to the east; however, the dam blocks fish access from this direction.

Photo 1-8. Denil fish pass at East Elm Street

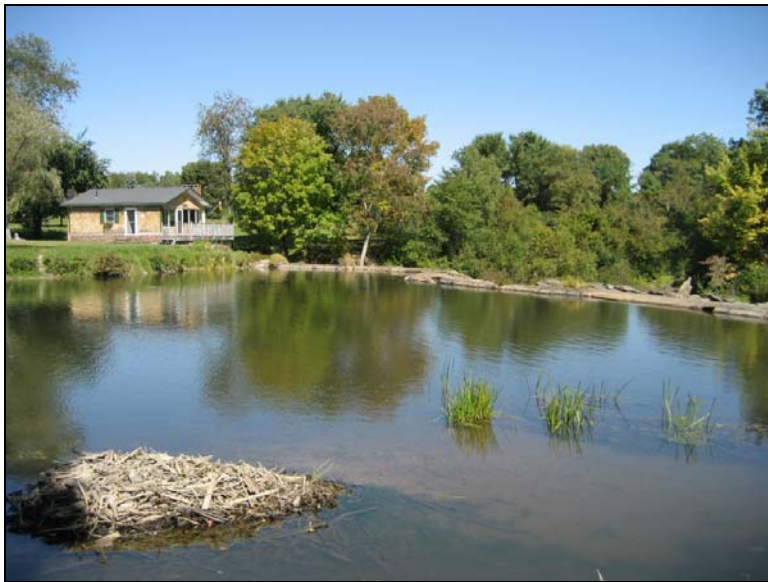
Photo 2-1. East Elm Street Dam and impoundment above; looking northeast. Stantec, September 19, 2007.

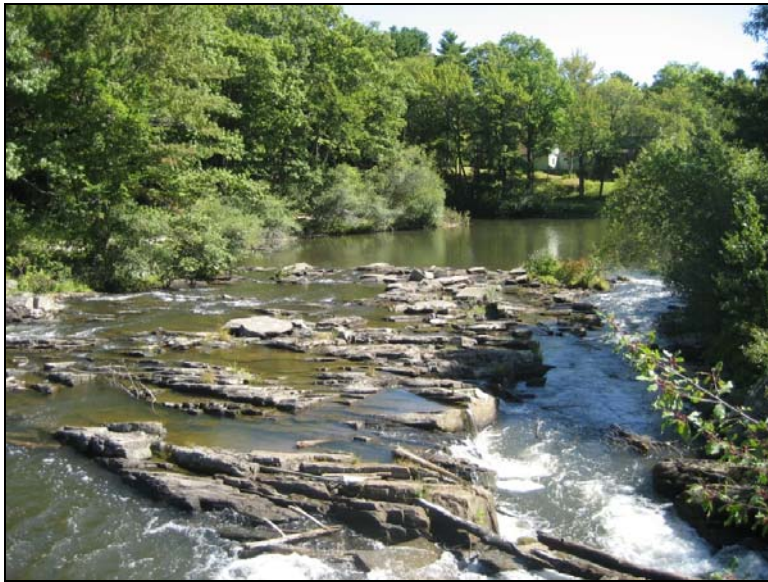
Photo 2-2. Royal River below Elm Street Dam; looking east. Stantec, September 19, 2007.

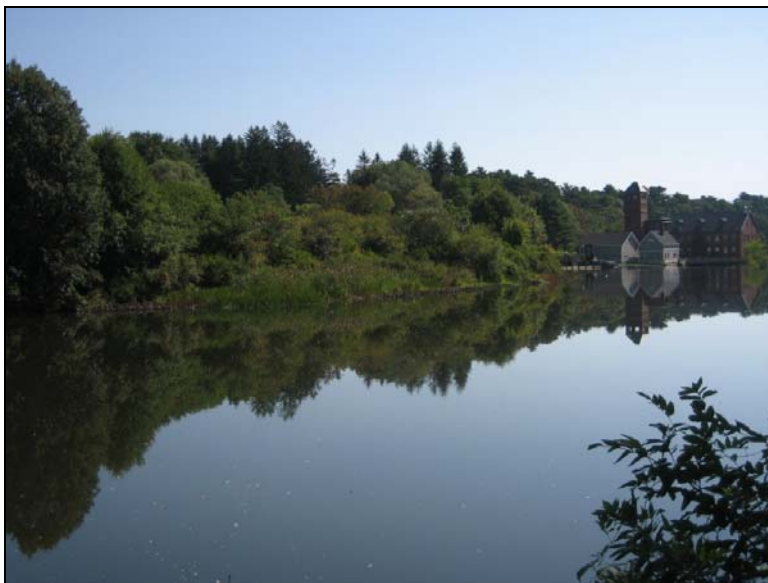
Photo 2-3. Impoundment above Bridge Street Dam, looking southeast at Sparhawk Mill. Stantec, September 20, 2007.

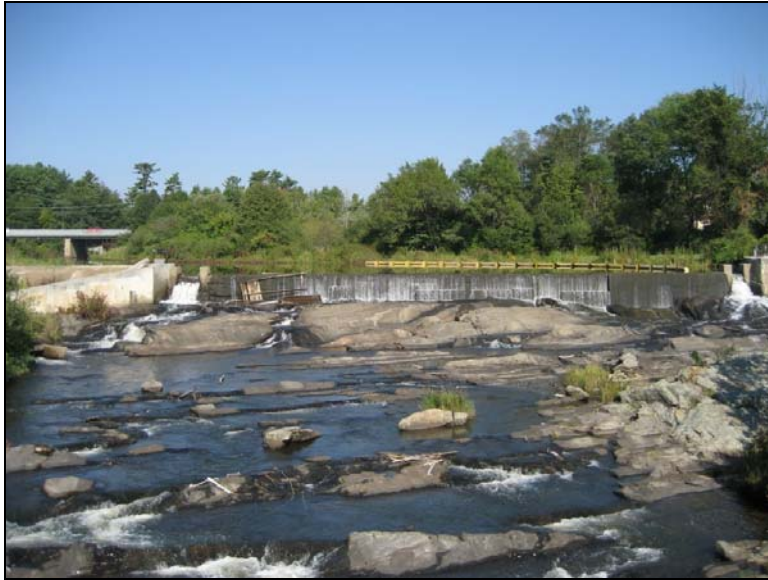
Photo 2-4. Bridge Street Dam, looking north. Stantec, September 20, 2007.

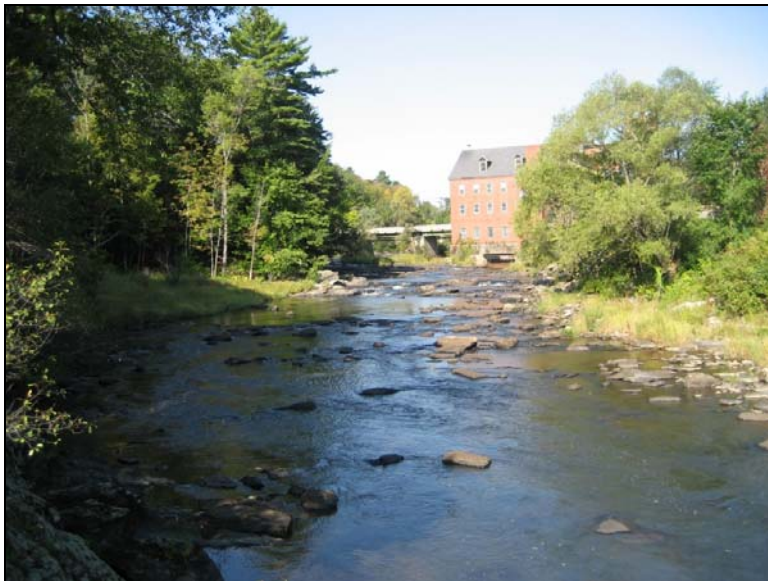
Photo 2-5. Looking upriver at Sparhawk Mill, to the northwest. River banks are gradual and rocky on this stretch of the river. Stantec, September 19, 2007.

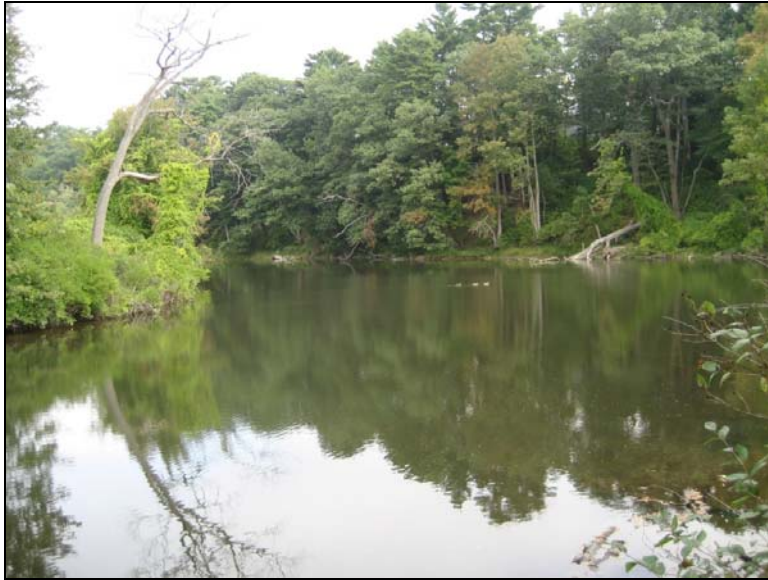
Photo 2-6. Looking upriver from Grist Mill Park, to the north. River banks are steep along north side. Stantec, September 19, 2007.

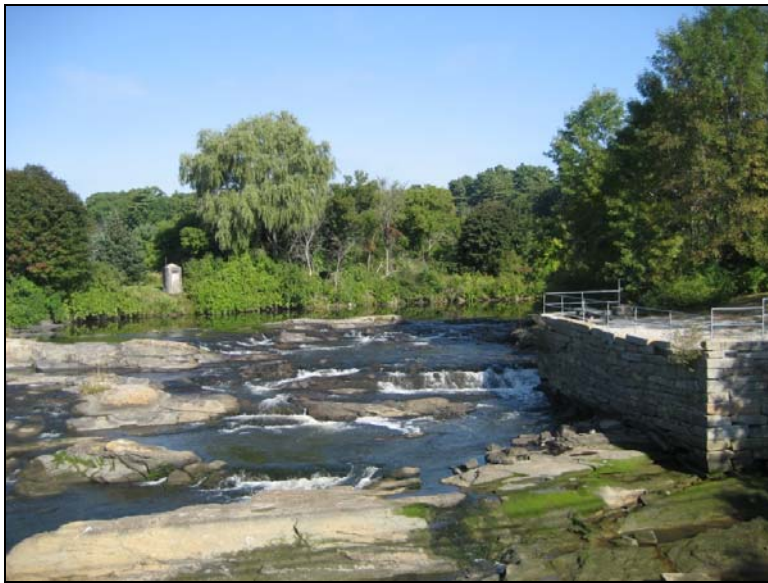
Photo 2-7. Lower Falls west of Route 88; looking north from Grist Mill Park. Stantec, September 19, 2007.

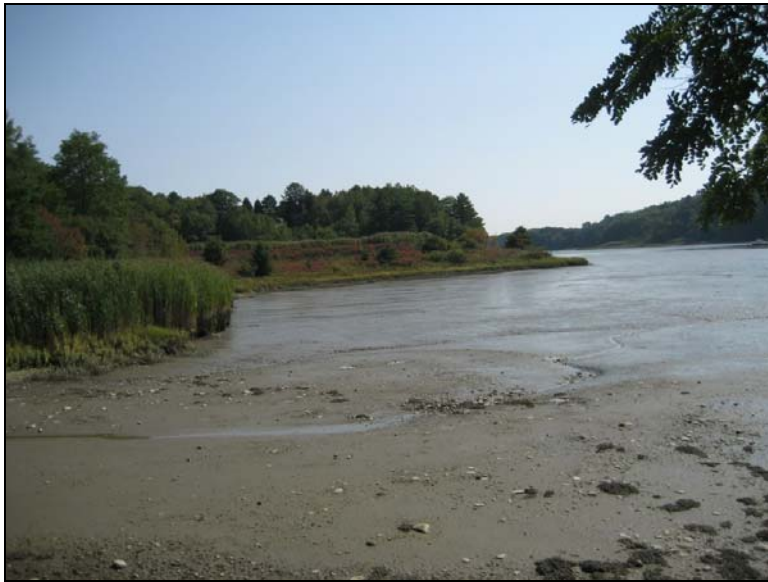
Photo 2-8. Looking southeast down the river from the public boat ramp off Old Shipyard Road. The demarcation from freshwater to saltwater occurs below the Lower Falls at Grist Mill Park. Stantec, September 19, 2007.

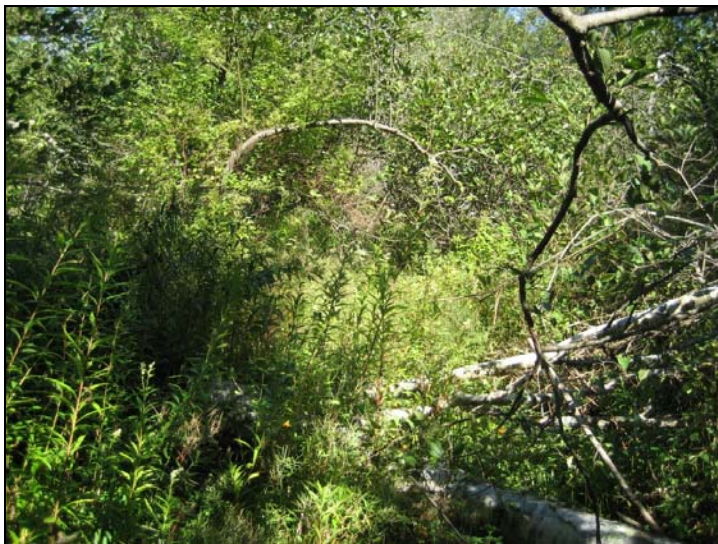
The wetland is a fairly small, isolated scrub-shrub wetland located at the southwestern end of the Royal River Park. It appears to be receiving groundwater discharge from the banks of the railroad that is located along the wetland's southern boundary. Dominant shrubs include red osier dogwood (*Cornus sericea*) and speckled alder (*Alnus incana*). Herbaceous species include jewelweed (*Impatiens capensis*), American willow-herb (*Epilobium ciliatum*), Canada goldenrod (*Solidago canadensis*), and swamp buttercup (*Ranunculus hispidus*). There are some scattered black willow trees present in the overstory. The area was saturated to the surface at the time of the visit. The construction of the rail road has disturbed this area and has likely altered the hydrology. It appears that the drainage from the wetland is channeled under the park and outlets to the river via a culvert.

Photo 2-9. Wetland 2. Scrub-shrub wetland on southwest end of the Royal River Park. Stantec, September 19, 2007.

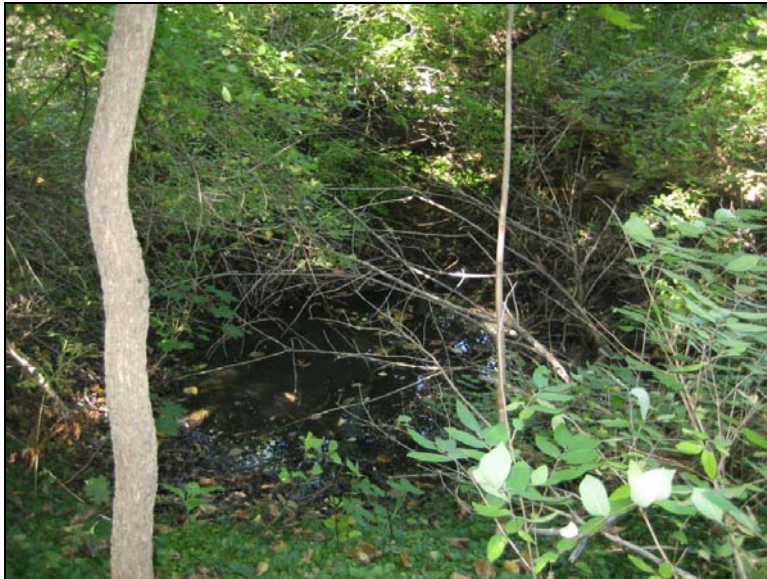
Wetland 3 is a very small isolated basin located southeast of Wetland 2. It is approximately 20 square feet in size and held approximately six inches of standing water at the time of the visit. It is surrounded by Morrow's honeysuckle, but there is no associated wetland vegetation. This wetland appears to be man-made, possibly a result of excavation activities. Stantec observed several green frogs (*Rana clamitans*) within the wetland. A springtime survey would need to be conducted to determine if the pool is being utilized by breeding amphibians.

Photo 2-10. Wetland 3. A very small isolated basin southeast of Wetland 2. Stantec, September 19, 2007.

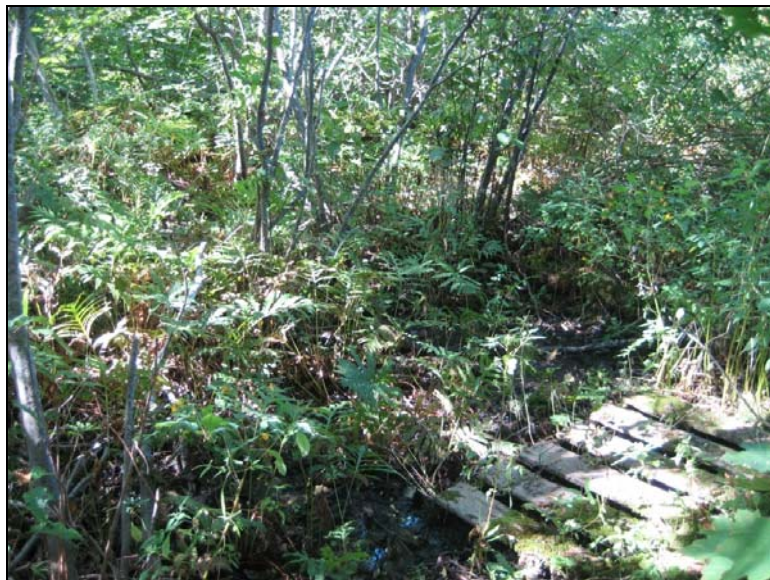
Wetland 4 appears to transition from a scrub-shrub to a forested wetland. It is located south of W-2 along the southwest boundary of the Royal River Park. Dominant trees in the overstory include gray birch (*Betula populifolia*), American elm, and black willow. Speckled alder dominates the shrub layer. Common herbaceous species include sensitive fern (*Onoclea sensibilis*), jewelweed, and American willow-herb. The area was inundated at the time of the visit, and remnants of a makeshift wooden bridge were observed. Similar to W-2, this wetland drains under the park and outlets into the river. Nearby within the shrub thicket are remnants of what appears to have been a building and a large pile of bricks. This may have been the site of a brick factory at one time.

Photo 2-11. Scrub-shrub and forested wetland located along the southwestern boundary of the Royal River Park with remnants of a wooden bridge in the foreground. Stantec, September 19, 2007.

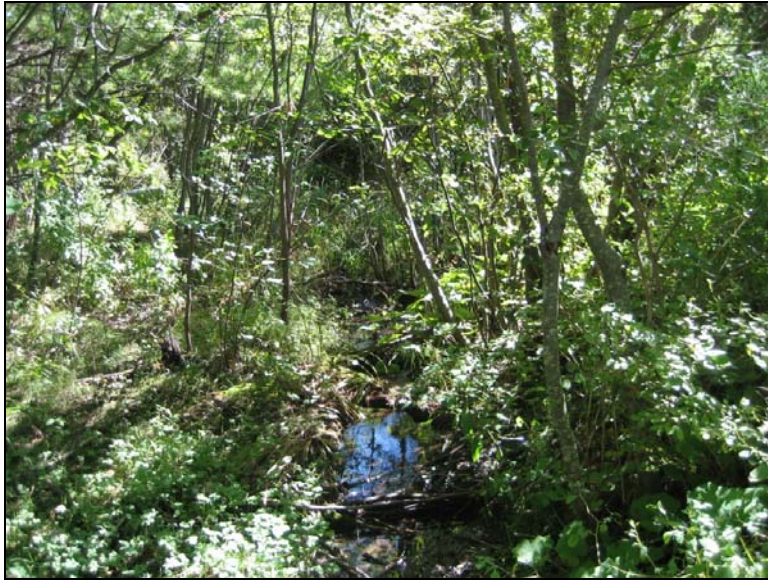
Wetland 5 is primarily a scrub-shrub wetland located north of the Yarmouth Elementary School. The park walkway is adjacent to the wetland. Dominant shrubs include red osier dogwood and common buckthorn. Common herbaceous species include jewelweed, swamp buttercup, soft rush (*Juncus effusus*), Canada bluejoint (*Calamagrostis canadensis*), coltsfoot (*Tussilago farfara*), and broad-leaved cat-tail (*Typha latifolia*). A few black willow and American elm trees are present in the overstory. At the time of the site visit, Wetland 5 was saturated to the surface and contained areas of inundation. It receives flow from a culvert at the southern end and drains northward to the river via culverts under the walkway. The construction of the school and the introduction of the paths likely altered the hydrology in this area.

Photo 2-12. Wetland 5. Scrub-shrub wetland with some inundation. This portion of the wetland is adjacent to the walkway to the north; looking east. Stantec, September 20, 2007.

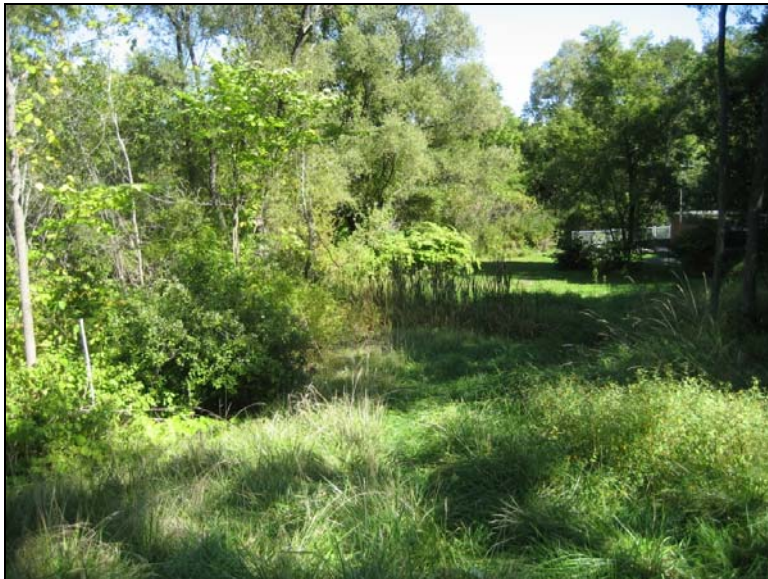
Photo 2-13. Wetland 5. Looking north at the small emergent portion of the wetland located between two areas of scrub shrub wetlands. Stantec, September 19, 2007.

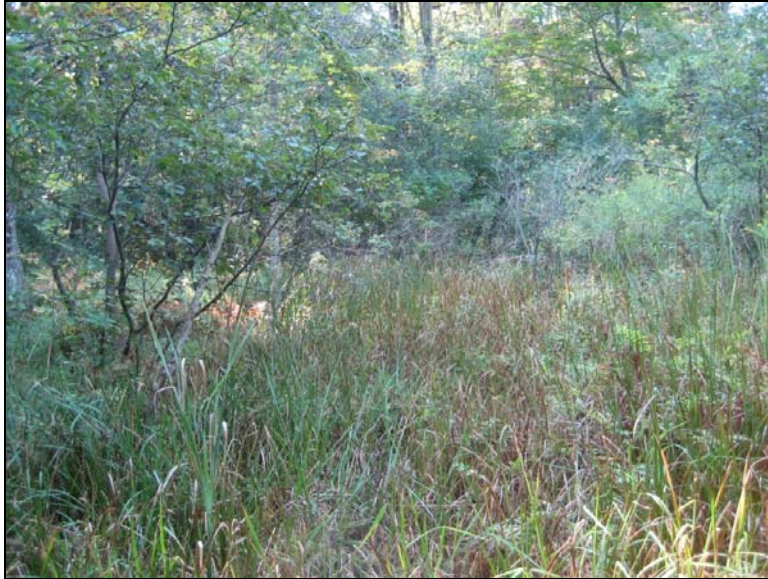
Photo 2-15. Wetland 7. Scrub-shrub wetland looking southwest. Stantec, September 20, 2007.

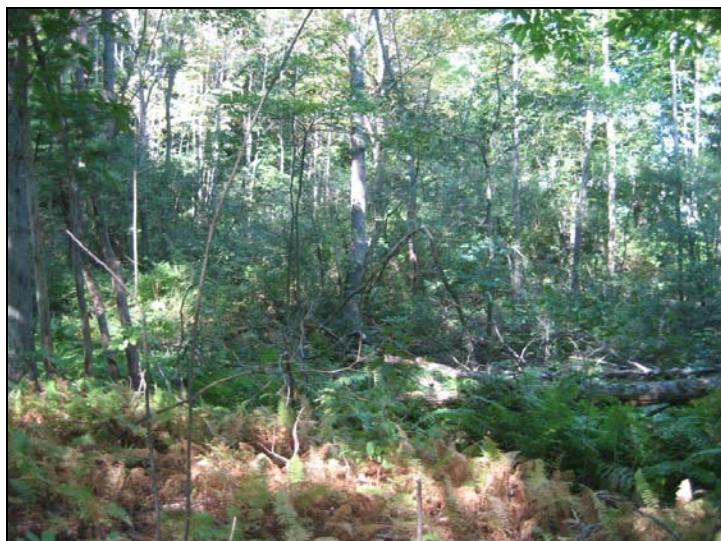
Wetland 8 is located southwest of the Bridge Street Dam, just northeast of Yarmouth Falls Apartments. There is a paved walkway from the apartments that borders the wetland to the east which intersects with the main walkway. The wetland appears to be a scrub-shrub wetland transitioning into a forested wetland. Red maple trees dominate the overstory. Winterberry (*Ilex verticillata*) and common buckthorn are common in the understory. Dominant herbaceous species include sensitive fern, cinnamon fern (*Osmunda cinnamomea*), and jewelweed. At the time of the site visit, the area was saturated to the surface with some inundation. The wetland drains to the river via a culvert under the walkway.

Photo 2-16. Wetland 8. A scrub-shrub and forested wetland southwest of the Pathway along the river. Stantec, September 20, 2007.

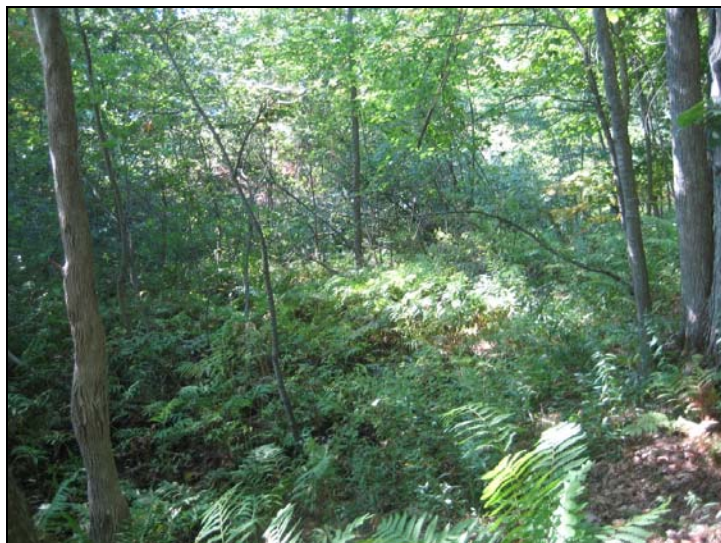
The wetland is located west of Bridge Street, just east of Wetland 8. It is predominantly forested and contains a perennial stream. Dominant trees in the overstory include gray birch and red maple. Common shrubs include speckled alder and willows. The herbaceous layer is dominated by sensitive fern. Purple loosestrife also occurs within the wetland. The stream is approximately 1.5 feet wide with a mix of cobble and mud substrate. It flows to the river via a culvert under the walkway.

Photo 2-17. Wetland 9 & Stream 2. Forested wetland west of Bridge Street on the south side of the river, looking southwest. Stantec, September 20, 2007.

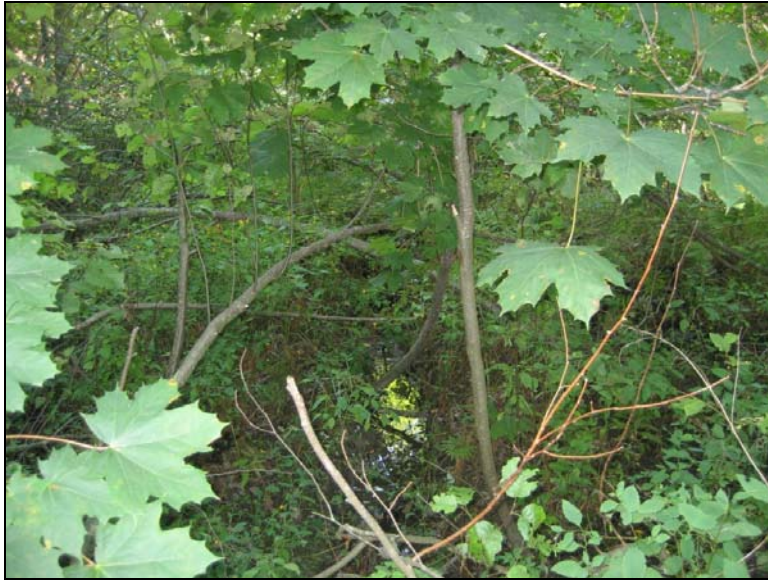
Photo 2-18. Perennial stream associated with Wetland 9. The stream is shaded by dense vegetation. Stantec, September 20, 2007.

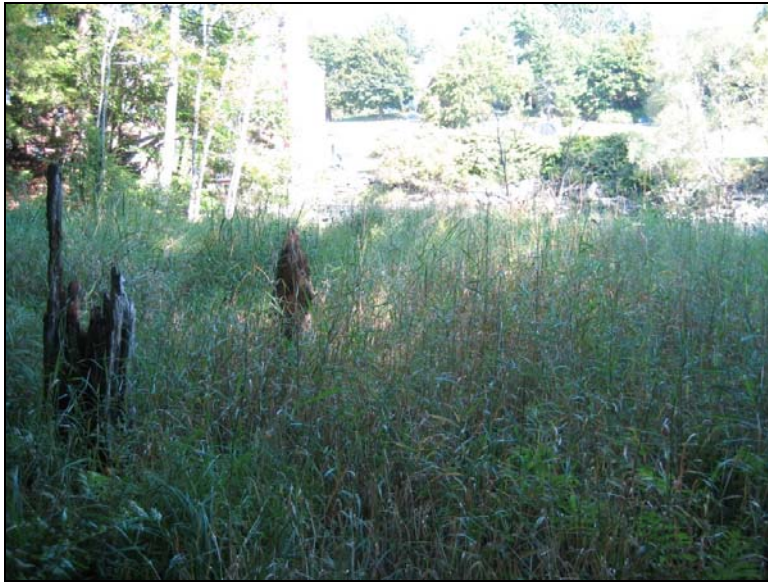
The emergent portion of the wetland complex is located adjacent to the river at the north end. Dominant herbaceous species include reed canarygrass, cinnamon fern, jewelweed, and purple loosestrife. The stream flows just inside the scrub-shrub portion, adjacent to the Millpoint parking lot, and flows northeast to the river. It had a steady flow at the time of the site visit. It is likely that the stream may have been impacted and the hydrology altered when the Millpoint Apartments were constructed.

Photo 2-19. Wetland 10. Emergent wetland adjacent to the river. Stantec, September 20, 2007.

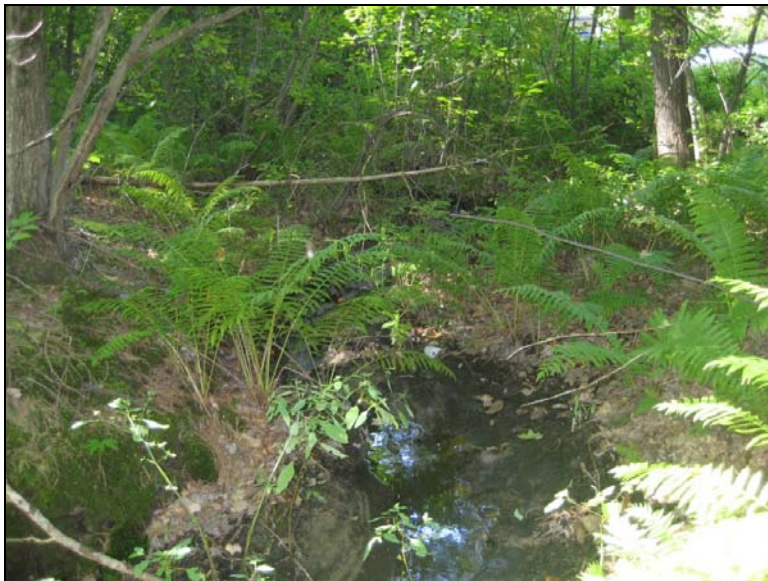
Photo 2-20. Wetland 10. Perennial stream. Stantec, September 20, 2007.

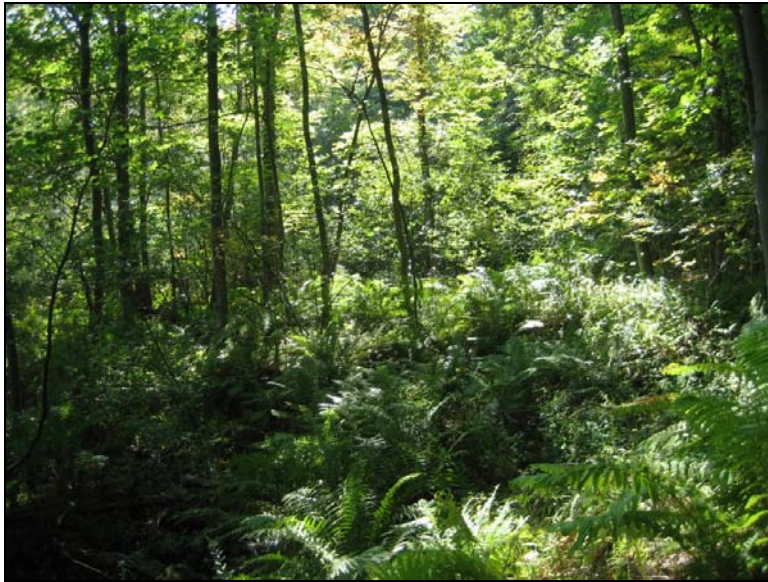
Photo 2-21. Wetland 10. Forested wetland south of Millpoint Apartments. Stantec, September 20, 2007.

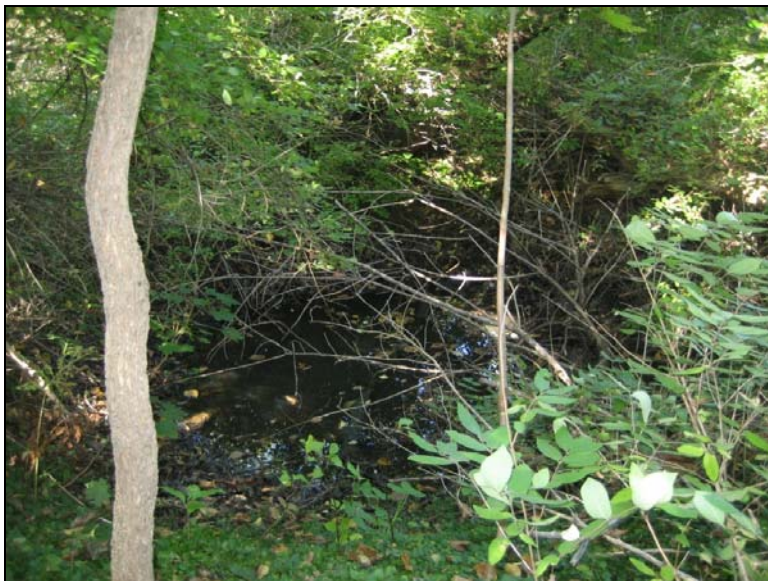
The scrub-shrub portions of the wetland are dominated by speckled alder, winterberry, and common buckthorn. Herbaceous species within the scrub-shrub portion of the wetland are similar to those found in the forested portion. The scrub-shrub wetland located adjacent to Grist Mill Lane appears to be transitioning to a forested wetland. In this area of the wetland complex, a small flooded depression was observed. Based the watermarks on the surrounding vegetation, it appears that water pools here for long periods throughout the year and could potentially provide breeding habitat for vernal pool species. However, a springtime survey would be necessary to confirm this.

Photo 2-22. Wetland 10. Potential vernal pool within scrub-shrub wetland off Grist Mill Lane. Stantec, September 20, 2007.

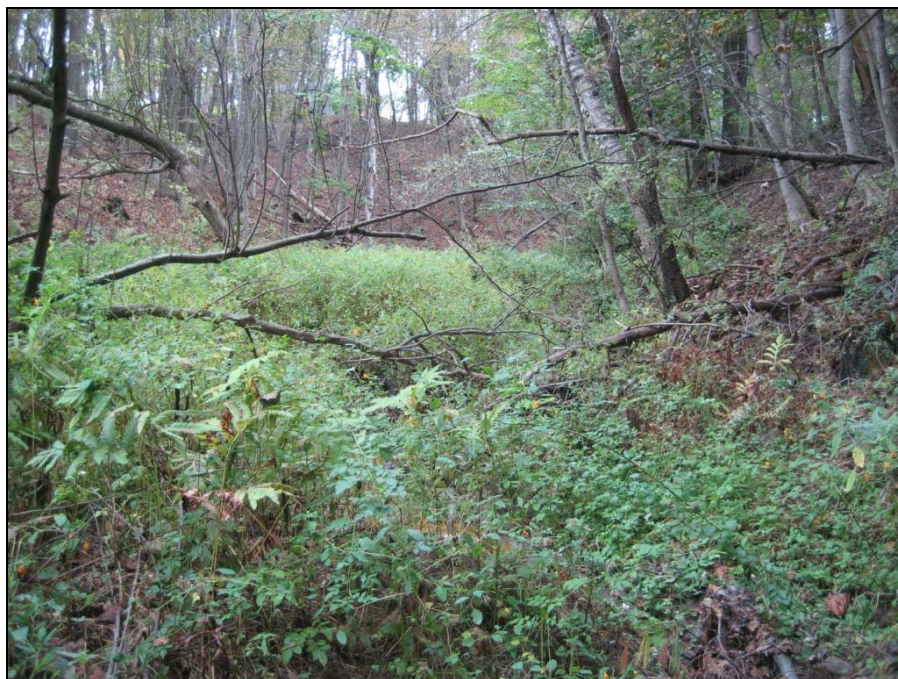
Wetland 11 is located on the south side of Route 88 across from Lower Falls Landing. It is a narrow fringe scrub-shrub wetland associated with a perennial stream. Dominant species include speckled alder shrubs, American Elm saplings, and jewelweed in the herbaceous layer. The wetland and stream are located between steep banks. At the time of the site visit, the stream was approximately two to three feet wide. The stream flows northward under Route 88 via a culvert and is directed through a drainage ditch in the parking lot of Lower Falls Landing, where it is then directed to the river via a culvert under the parking area.

Photo 2-23. Wetland 11. Scrub-shrub wetland associated with a perennial stream, looking southwest. Stantec, September 20, 2007.

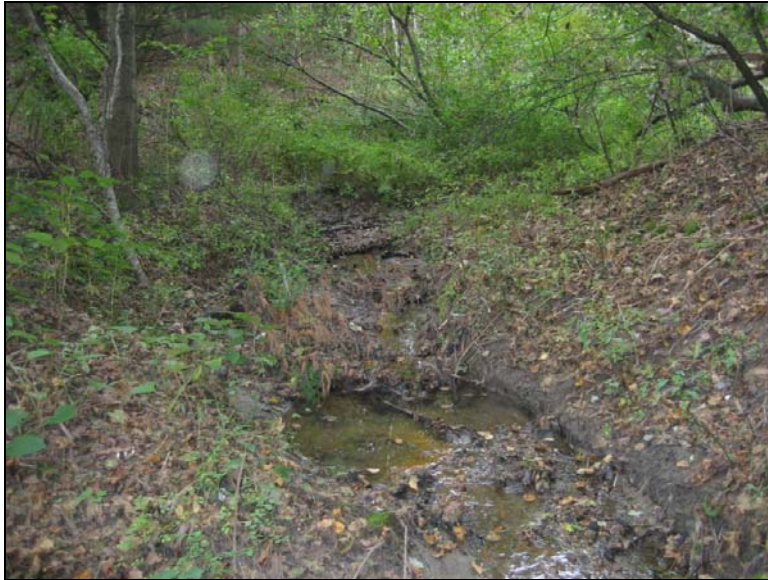
Photo 2-24. Wetland 11. Scrub-shrub wetland associated with a perennial stream; looking south. Stantec, September 20, 2007.

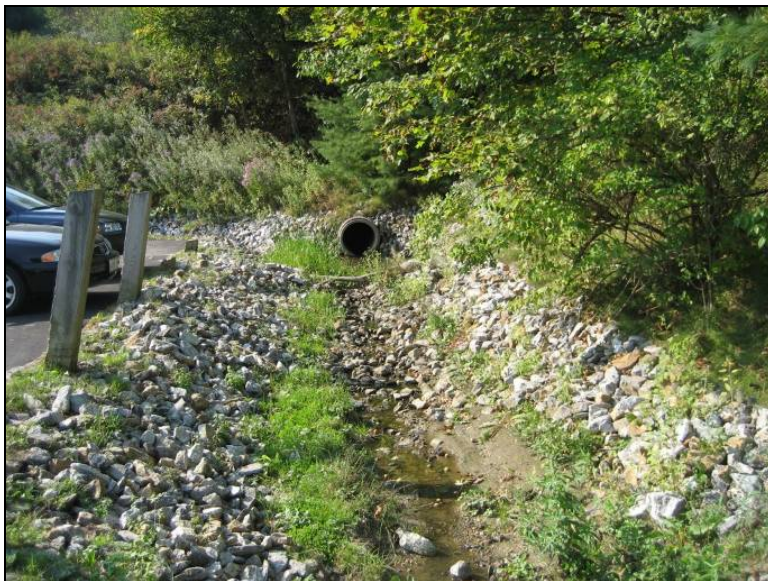
Photo 2-25. Drainage basin for Wetland 11, located on the north side of Route 88 in the Lower Falls Landing parking area. Stantec, September 20, 2007.

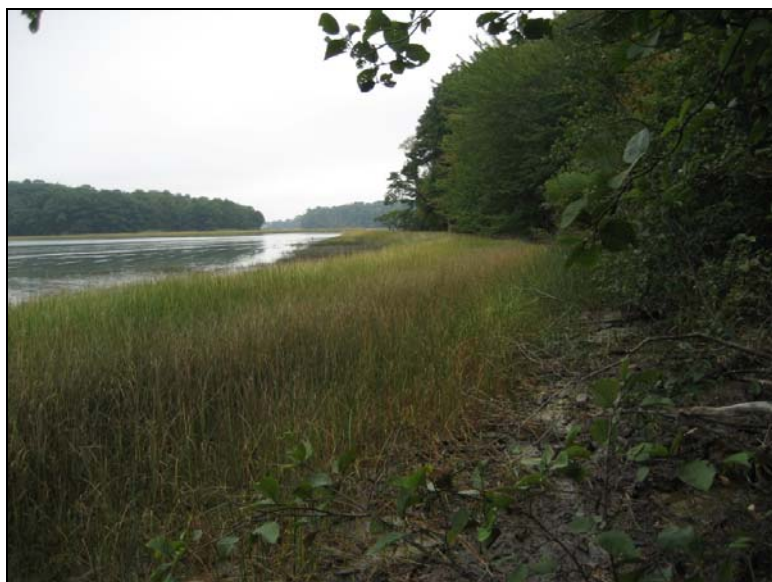
Wetland 12 is located adjacent to the south side of the river, north of River View and Holly Cross cemeteries. Yankee Marina and Boatyard is located to the west and the Yarmouth Sewer District Treatment plant to the east. There are very steep, wooded banks along the southern boundary of the wetland. The coastal wetland is a narrow fringe bordering the river and is dominated by smooth cordgrass (*Spartina alterniflora*), salt hay grass (*Spartina patens*), saltmarsh bulrush (*Bolboschoenus robustus*), seaside goldenrod (*Solidago sempervirens*), stiff leaf quackgrass (*Agropyron pungens*), and common reed (*Phragmites australis*). Adjacent to the coastal wetland is a scrub-shrub wetland fringe dominated by speckled alder and winterberry. Common herbaceous species include sensitive fern, cinnamon fern, swamp buttercup, drooping sedge (*Carex prasina*), and jewelweed. At one point, the scrub-shrub wetland broadens to include a small forested wetland dominated by red maple and balsam fir. A few narrow drainages were observed along the steep slopes.

Photo 2-26. Wetland 12. Coastal emergent wetland looking east downriver. Stantec, September 20, 2007.

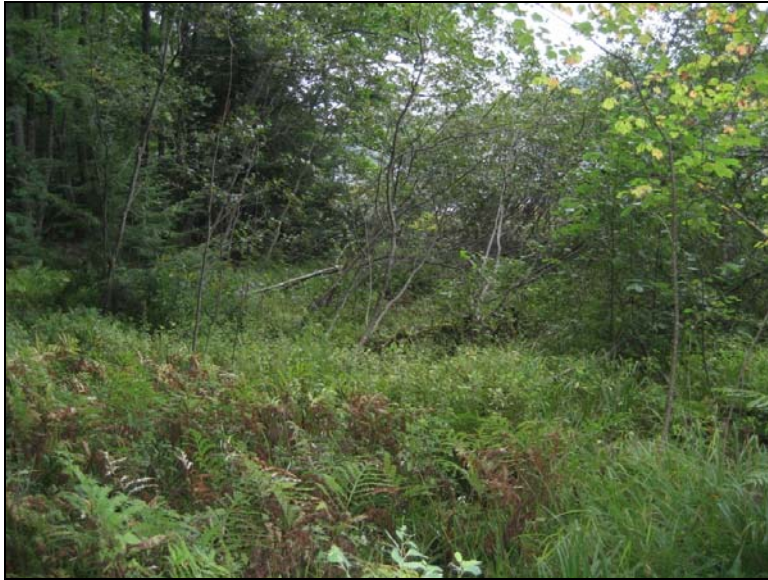
Photo 2-27. Wetland 12. Scrub-shrub wetland adjacent to the coastal wetland; looking north. Stantec, September 20, 2007.

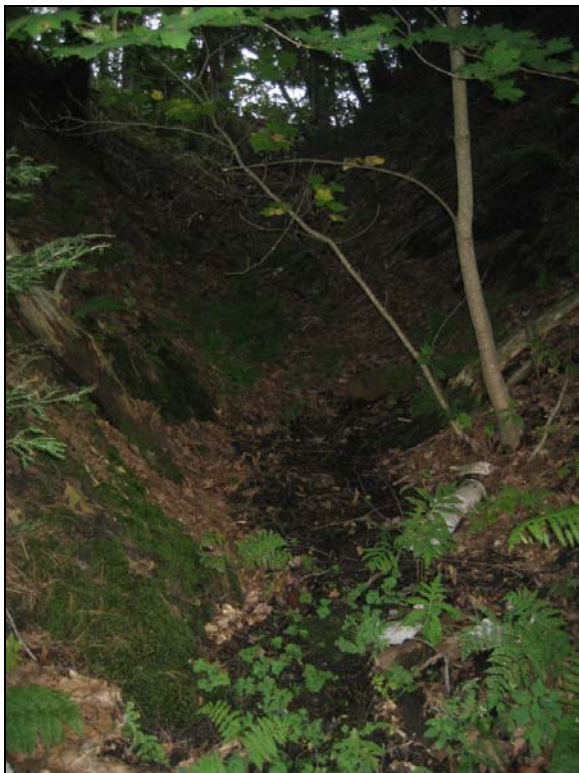
Photo 2-28. Narrow drainage along the steeply wooded slopes south of Wetland 12. Stantec, September 20, 2007.

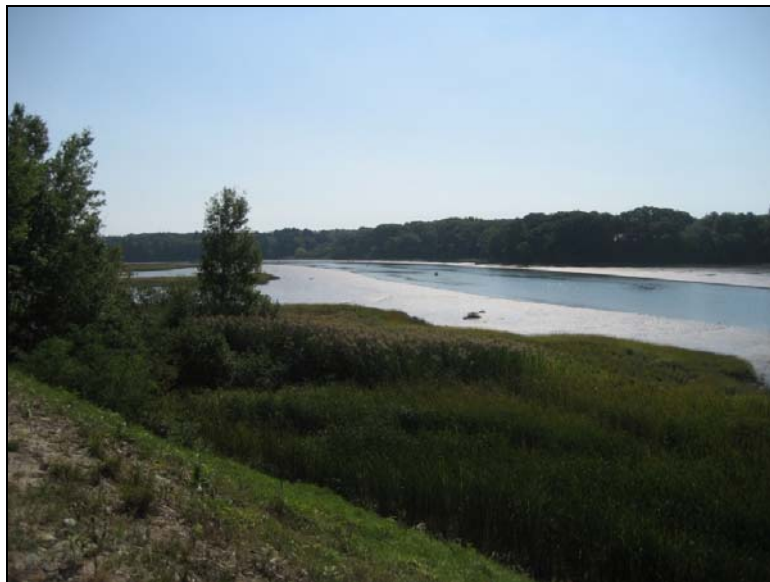
Wetland 13 is located on the north side of the river east of the Royal River Boat Yard. It is a large salt marsh dominated by narrow-leaved cat-tail (*Typha angustifolia*), common reed, smooth cordgrass, salt hay grass, and seaside goldenrod. The wetland contains a *Spartina* Saltmarsh as mapped by the Maine Natural Areas Program. This community is considered rare in Maine and is ranked by MNAP as S3 (i.e., on the order of 20-100 occurrences).

Photo 2-29. Wetland 13. Coastal emergent wetland (salt marsh) located east of Royal River Boatyard, looking south. Stantec, September 20, 2007.

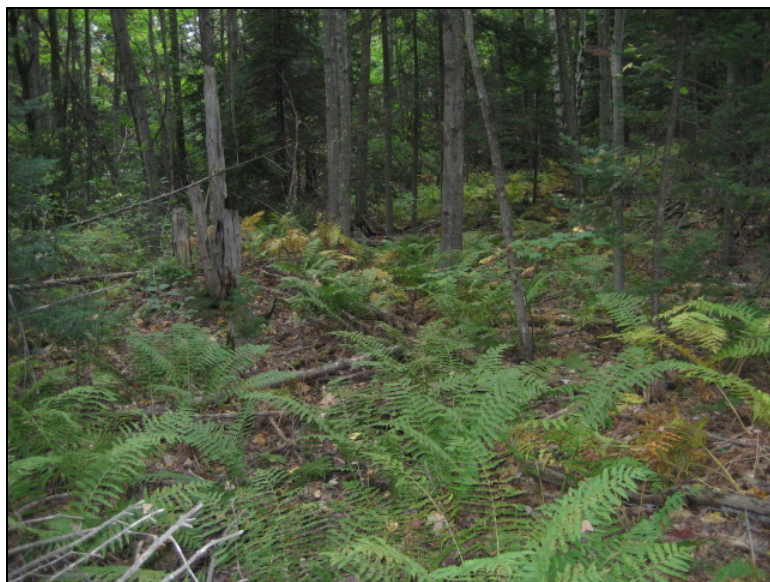
Wetland 14 is a small wetland area located in the woods northwest of Blueberry Cove. Red maple and balsam fir trees dominate the overstory. There is little to understory. The herbaceous layer is dominated by cinnamon fern.

Photo 2-30. Wetland 14. Small forested wetland northwest of Blueberry Cove Condominiums. Stantec, September 20, 2007.

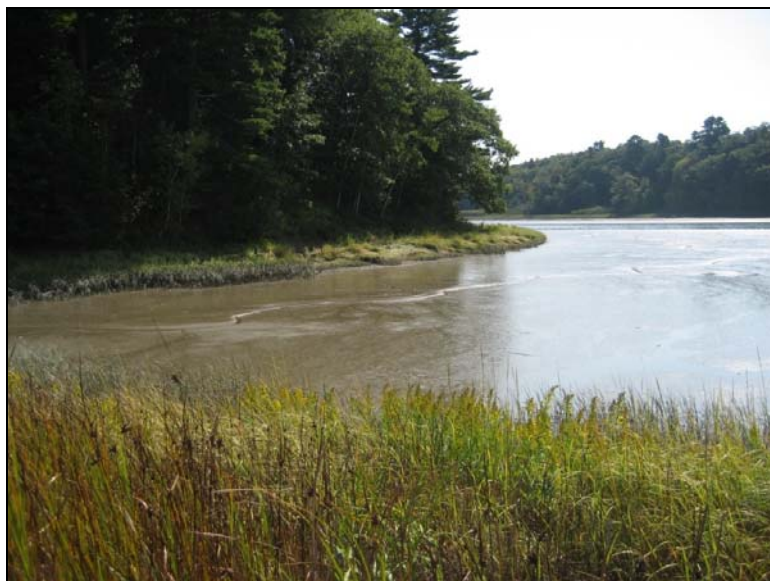
Wetland 15 is located along the shore of a small cove on the north side of the river, southwest of Blueberry Cove. It is a narrow fringe of coastal emergent wetland dominated by smooth cordgrass, salt hay grass, saltmarsh bulrush, and seaside goldenrod.

Photo 2-31. Wetland 15. Coastal wetland fringe southwest of Blueberry Cove Condominiums. Stantec, September 20, 2007.

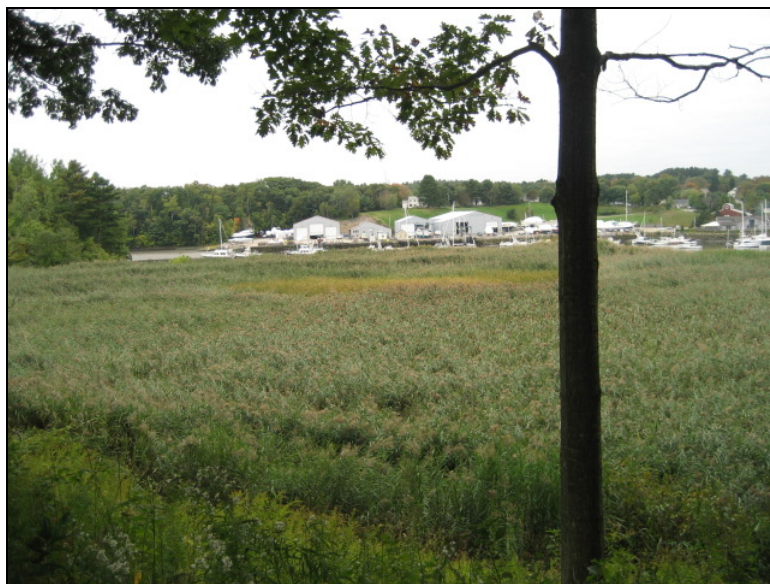
Wetland 16 contains spoils from an historic dredging of the harbor. It is a highly disturbed area dominated by common reed, an invasive species. A portion of the area is mapped on the NWI Map as palustrine unconsolidated bottom. However, the very dense phragmites stand and the limited scope of the study prevented verification of this mapping. There have been a number of nesting red-winged blackbirds (*Agelaius phoeniceus*) sighted within the wetland, and splashing water has been heard coming from the center portions of the wetland. A photograph taken at a higher elevation reveals an area that contains vegetation other than common reed. It is likely that some areas within the wetland are flooded during the growing season.

Photo 2-32. Wetland 16, looking south. A large stand of common reed covers a relic spoils pile from harbor dredging that occurred circa 1970. Note the lighter green patches of vegetation; this may be the areas that are inundated during the growing season. Stantec, September 20, 2007.
