Royal River Corridor Study Yarmouth, Maine Natural Resource Reconnaissance Surveys

July 2008

Introduction

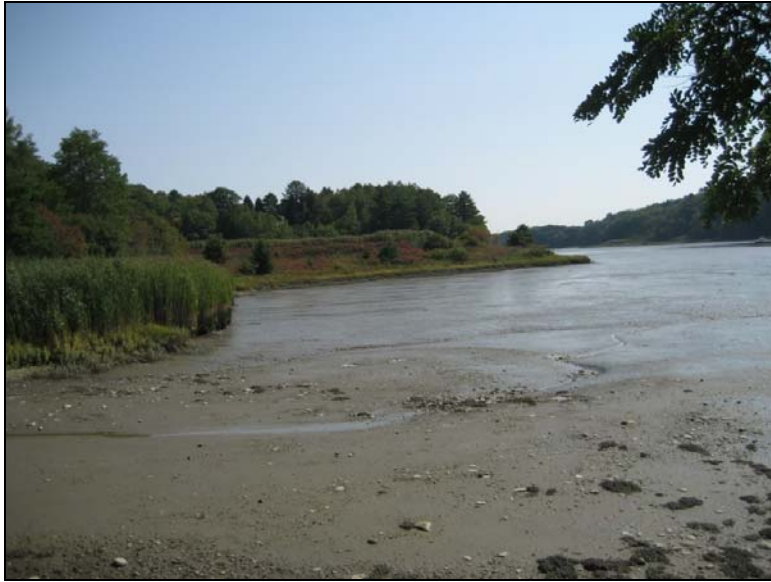
Photo 2-33. Wetland 16, looking southeast from the public boat launch off Old Shipyard Road. Stantec, September 20, 2007.

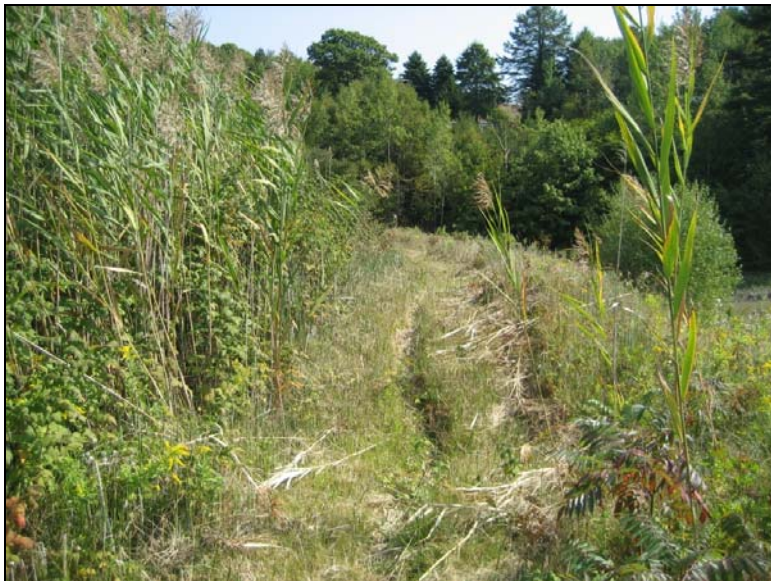
Photo 2-34. Wetland 16, looking east at a pathway around the stand of common reed. Stantec, September 20, 2007.

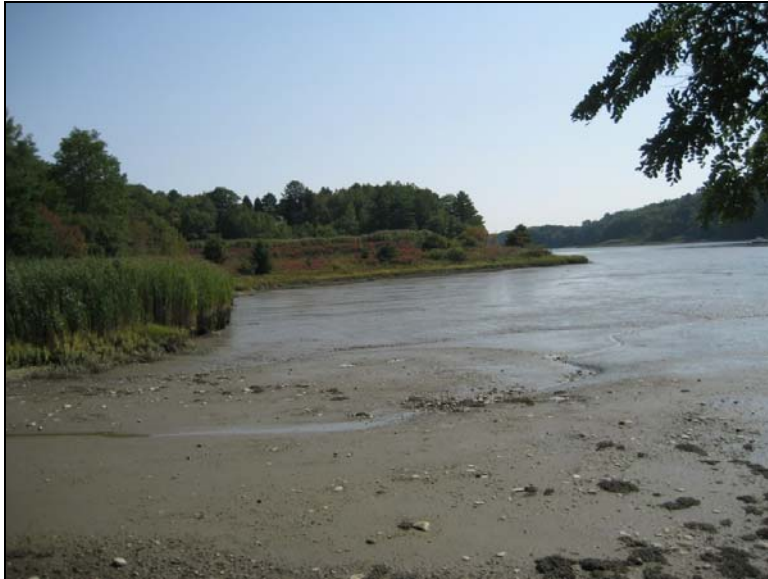
Wetland 17 is located east of the public boat launch and west of Wetland 16. It is a narrow fringe of emergent vegetation dominated by common reed.

Photo 2-35. Wetland 17 is in the foreground to the left of the frame; Wetland 16 is in the background. Stantec, September 20, 2007.

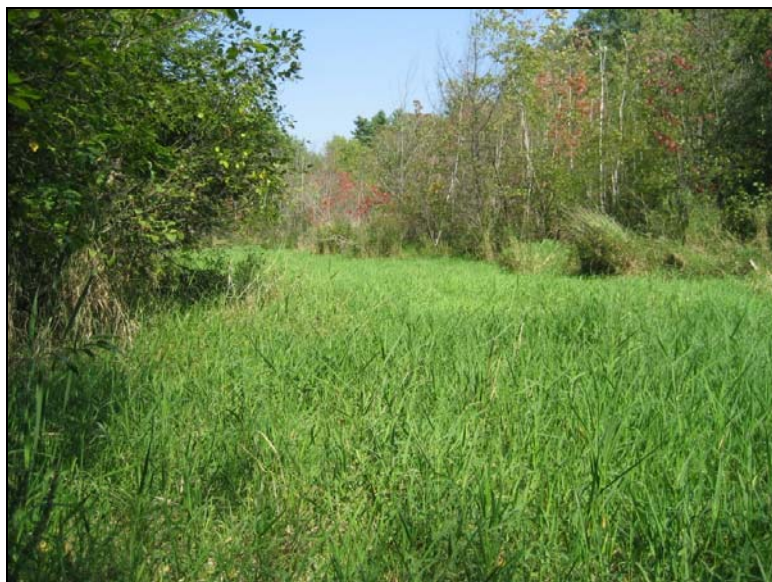
Wetland 18 is located east of Old Shipyard Road. It is primarily an emergent wetland with a narrow forested wetland fringe that broadens in the southeast corner. The wetland has been impounded by the parking area and exit road of the public boat launch. The wetland drains to the river via two metal culverts. Dominant herbaceous species include reed canarygrass, broad-leaved cat-tail, purple loosestrife, and sensitive fern. Speckled alder, common buckthorn shrubs, and red maple trees are common along the edges. Red maple and cinnamon fern dominate the larger forested area to the southeast. A narrow drainage channel between very steep banks drains into the wetland from east.

Photo 2-36. Wetland 18. Emergent and forested wetland east of Old Shipyard Road; looking north. Stantec, September 20, 2007.

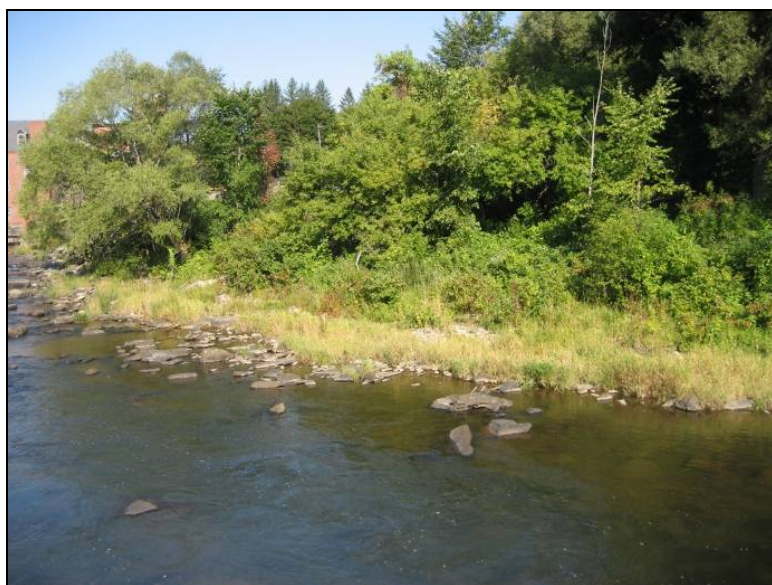
Photo 2-37. Wetland 19 located on the north side of the river east of the Sparhawk Mill. Stantec, September 20, 2007.

Wetland 19 is located adjacent to the north side of the river, downstream of Sparhawk Mill. It has a very narrow emergent fringe along the rocky shore. Reed canarygrass and purple loosestrife dominate the herbaceous layer. Dominant shrubs include speckled alder, red osier dogwood, and willow (*Salix* sp.). There are a few black willow trees present in the overstory. Several narrow drainage channels occur between steeply eroding banks that drain from Yankee Drive. One drainage empties into the eastern end of the wetland, and the other drains through an upland east of the wetland.

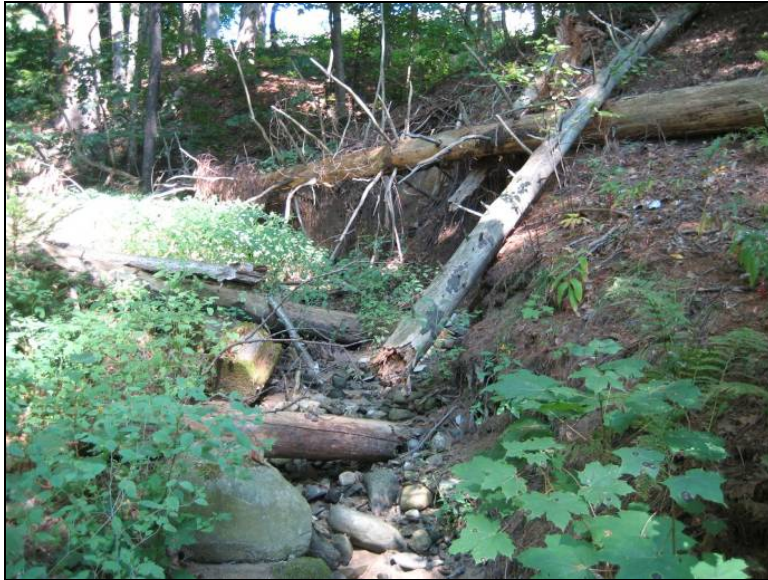
Photo 2-38. Wetland 19, a narrow drainage channel located between steeply eroding banks, draining from Yankee Drive to the north. Stantec, September 20, 2007.

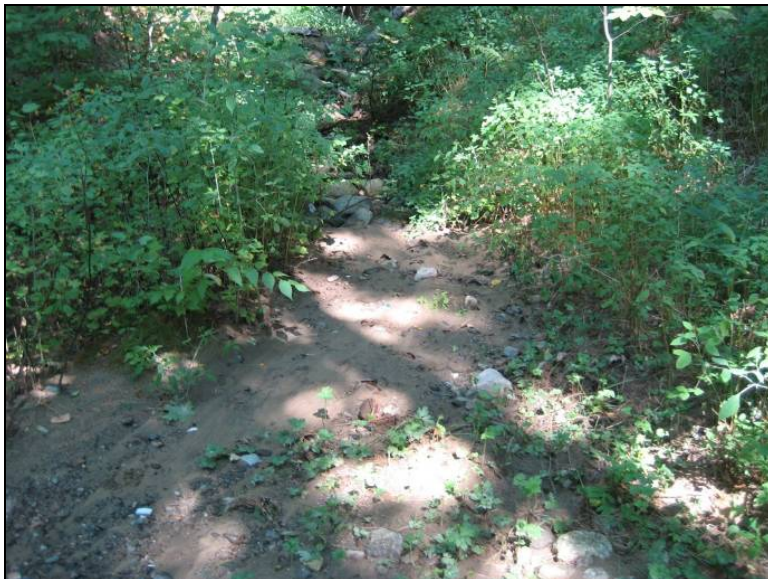
Photo 2-39. Wetland 19 drainage. Stantec, September 20, 2007.

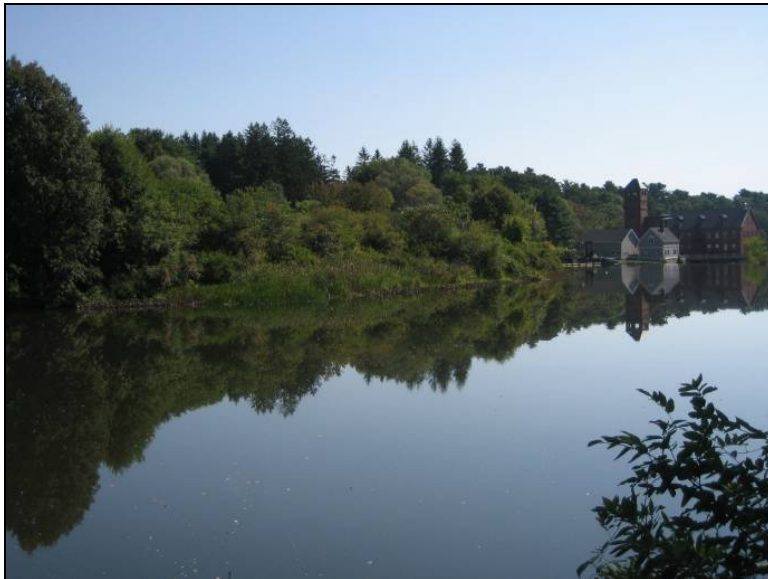
Photo 2-40. Wetland 20, a scrub-shrub, emergent wetland located east of Route One and south of the Down-East Village Motel & Restaurant. Stantec, September 20, 2007.

Wetland 20 is located on the north side of the river, east of Route 1 and south of the Down-East Village Motel & Restaurant. This wetland is densely vegetated and appears to be located at the base of steep slopes. Dominant shrubs include speckled alder, common buckthorn, and red osier dogwood. There are a few black willow trees in the overstory. Broad-leaved cat-tail dominates the emergent wetland, in addition to pickerelweed (*Pontederia cordata*). From the aerial photographs, there appears to be a stream along the southeast corner of the wetland. However, this stream was not field verified during this study.

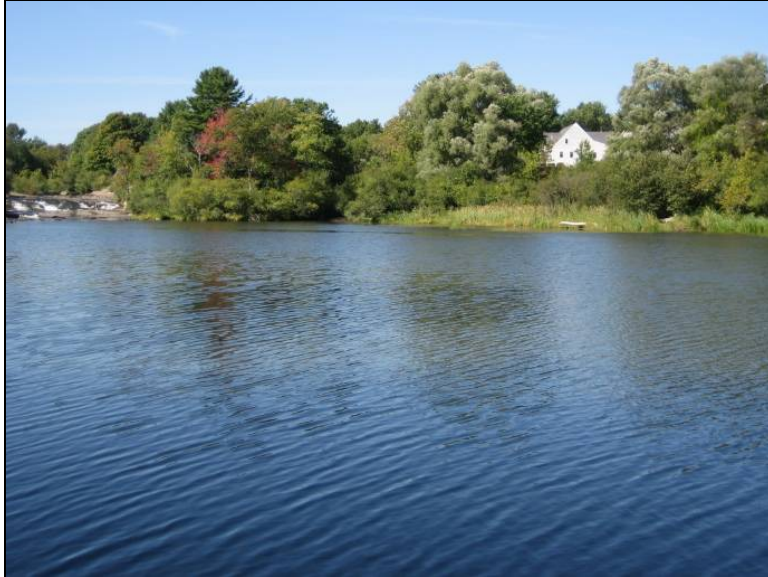
Photo 2-41. Wetland 21, looking northwest from the south side of the river. Stantec, September 20, 2007.

Wetland 21 is located on the north side of the river, west of Route One and south of Royal River Center/Forest Falls Drive. A perennial stream is associated with the eastern boundary of this wetland. Dominant shrubs include speckled alder, red osier dogwood, and common buckthorn. There are a few black willow trees in the overstory. Common emergent vegetation includes broad-leaved cat-tail, purple loosestrife, wool-grass (*Scirpus cyperinus*), reed canary grass, river bulrush, pickerel weed, bur-reed (*Sparganium* sp.), three-way sedge (*Dulichium arundinaceum*), and spotted joe-pye weed (*Eupatorium maculatum*). The

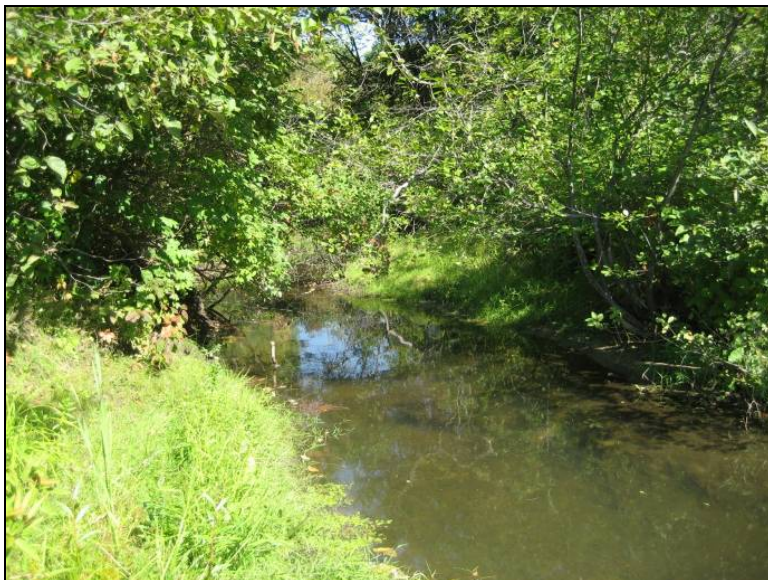
Photo 2-42. Perennial stream associated with Wetland 21. Stantec, September 20, 2007.

stream is approximately 4 to 5 feet wide and 8 to 10 inches deep. It drains from a cement box culvert behind the Seagrass Restaurant adjacent to the Yarmouth Post Office. The construction of Royal River Center to the north likely altered the hydrology of the stream.

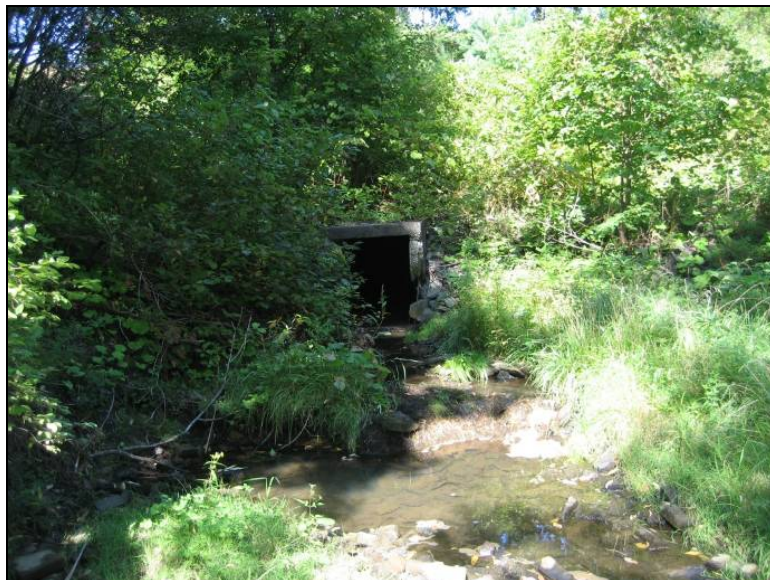
Photo 2-43. Perennial stream associated with Wetland 21 and box culvert behind the Seagrass Restaurant. Stantec, September 19, 2007.

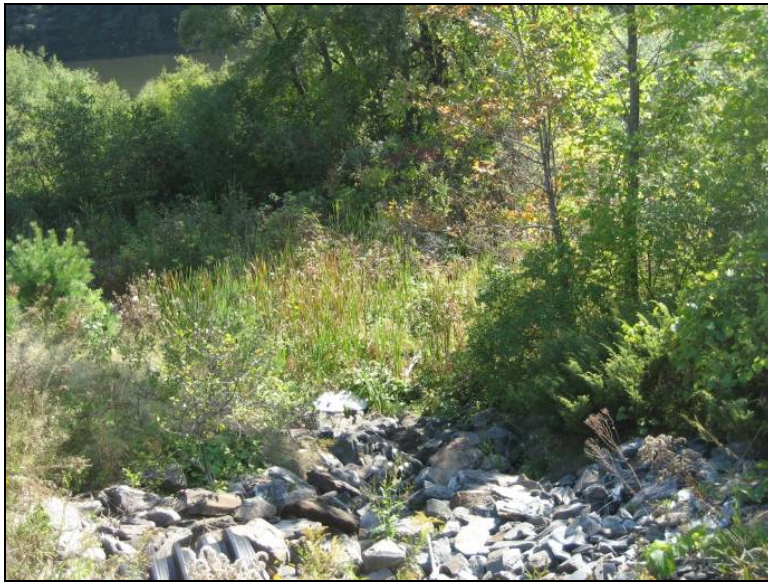
Photo 2-44. Wetland 22, a scrub-shrub wetland located west of W-21 and south of Royal River Center. Stantec, September 19, 2007.

Wetland 22 is located west of Wetland 20 and south of Royal River Center/Forest Falls Drive. It is a scrub-shrub wetland associated with a perennial stream. A detention basin has been constructed above the wetland, which has likely impacted the wetland hydrology. Dominant shrubs include speckled alder, red osier dogwood, and Morrow's honeysuckle. There are some black willow trees present in the overstory, and the detention basin contains some broad-leave cat-tail. The stream, which has been impacted by beaver (*Castor canadensis*) activity, is approximately two feet wide and contained less than one inch of flow at the time of the site visit. The substrate was primarily mud.

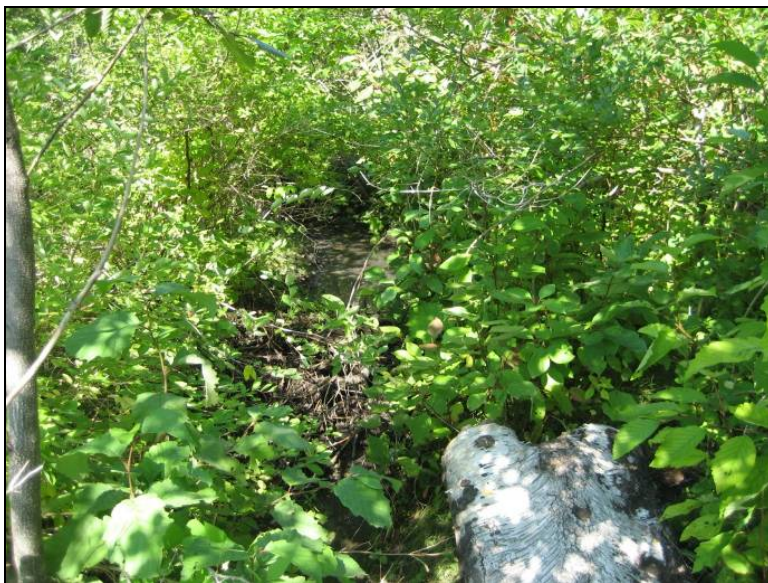
Photo 2-45. Wetland 22, perennial stream associated with W-22. It flows through dense vegetation and has been impacted by beaver activity. Stantec, September 19, 2007.

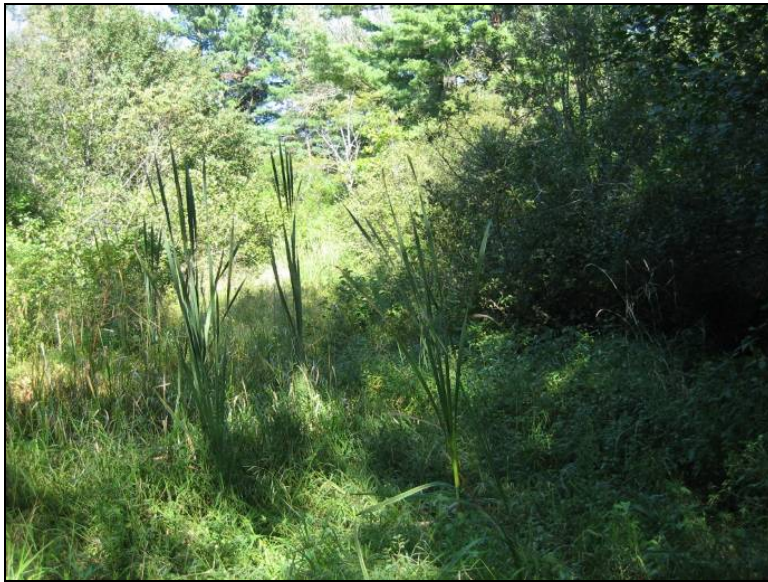
Photo 2-46. Wetland 23. A scrub-shrub wetland south of Melissa Drive. Stantec, September 19, 2007.

Wetland 23 is located at the western end of the study area, south of Melissa Drive. It is a scrub-shrub wetland that contains two perennial streams.

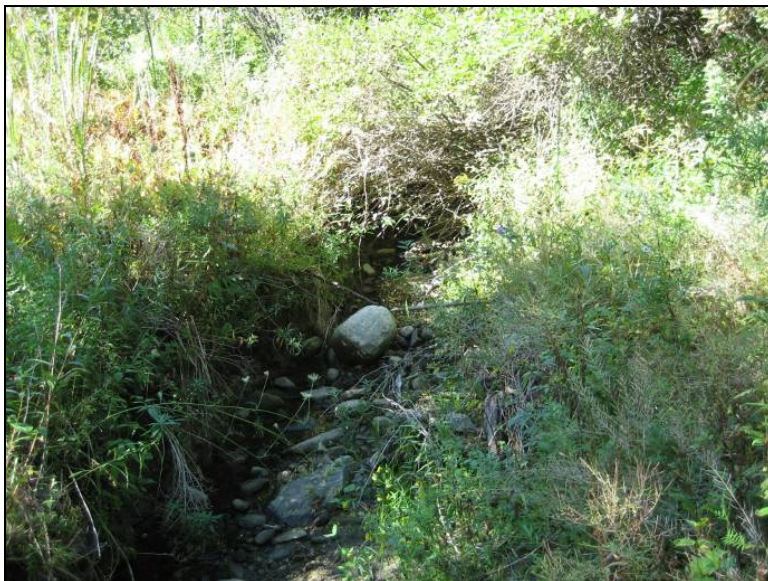
Photo 2-47. Wetland 23 and associated perennial stream. Stantec, September 19, 2007.

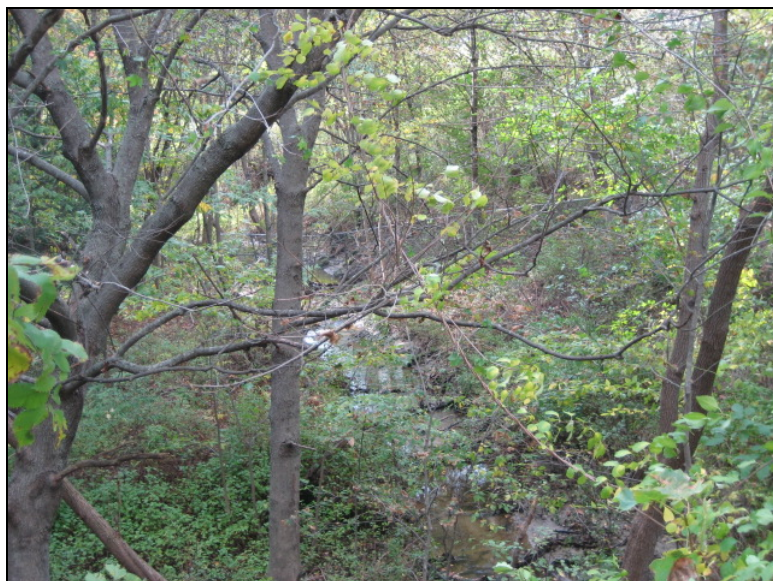
Photo 2-50. Wetland 24, a forested floodplain wetland south of Pleasant Street that contains a perennial stream. Stantec, September 20, 2007.

Wetland 24 is located on the south side of Pleasant Street. It is a forested floodplain wetland occurring between steep slopes and is associated with a perennial stream. The overstory is dominated by American elm, green ash (*Fraxinus pennsylvanica*), and red maple. Dominant shrubs include European buckthorn and multiflora rose. Sensitive fern and swamp buttercup are common in the herbaceous layer. The wetland and stream extend beyond the study area to the south. The stream flows northerly under Pleasant Street and exits via a culvert below Pleasant Street. The stream flows for a short distance before it is directed under Route 88 and exits into the river on the north side of Route 88, east of Yarmouth Boat Sales.

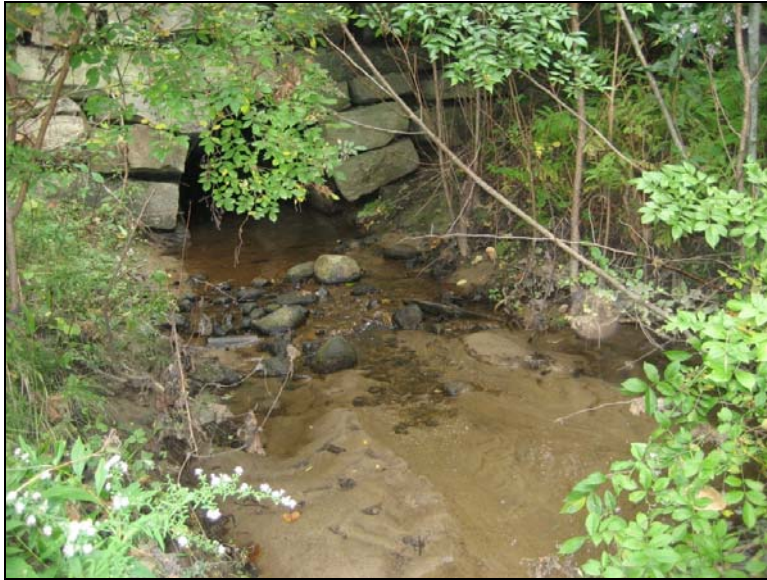
Photo 2-51. Wetland 24, perennial stream associated with Wetland 24. Exiting north of Pleasant Street. Stantec, September 20, 2007.

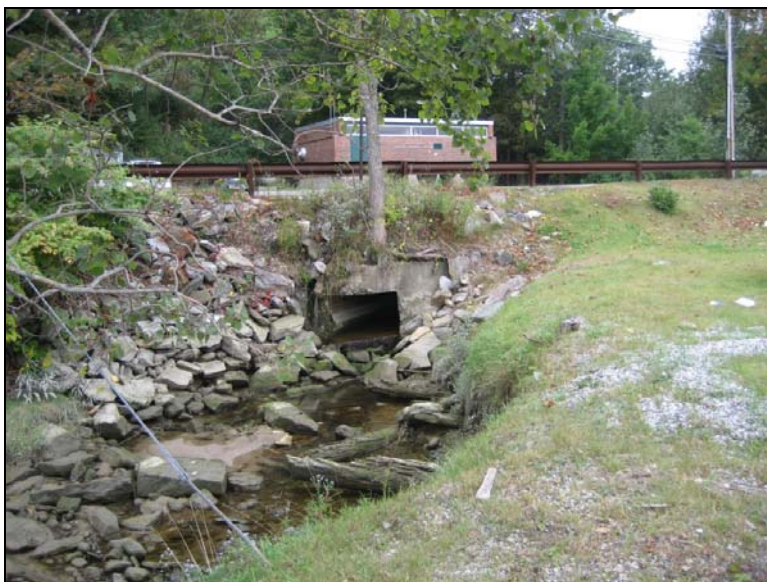
Photo 2-52. Perennial stream associated with Wetland 24, exiting north of Route 88 to the river. Stantec, September 20, 2007.

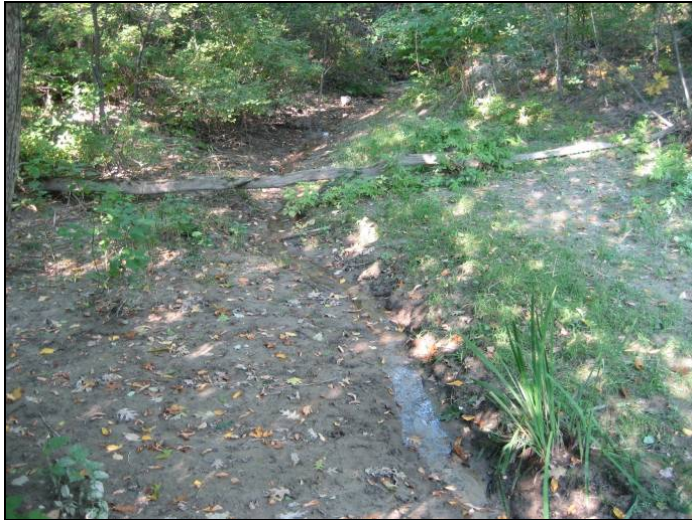
Photo 2-48. Potential stream draining from Wetland 2 via a drain system under Royal River Park. Stantec, September 19, 2007.
