# Casco Bay Monitoring Network: DEP eelgrass monitoring update

Angela Brewer  
Section Leader, Marine Unit  
Division of Environmental Assessment  
Bureau of Water Quality

MAINE DEPARTMENT OF ENVIRONMENTAL PROTECTION

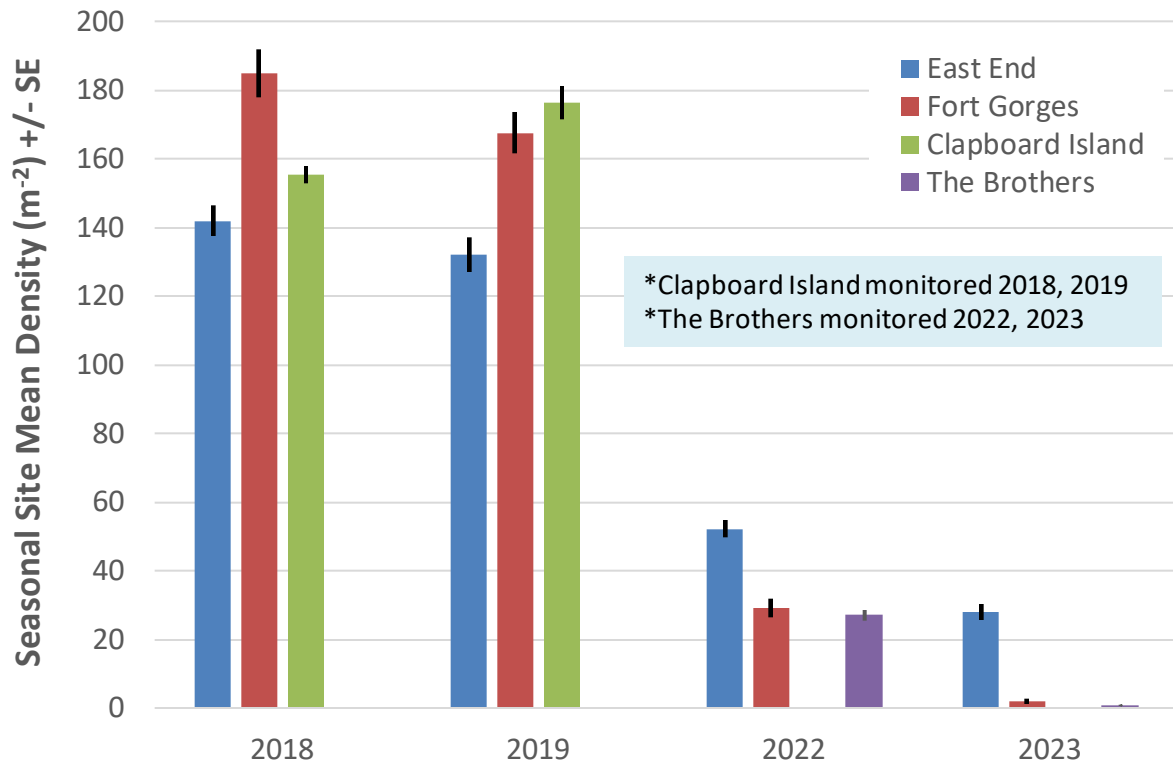
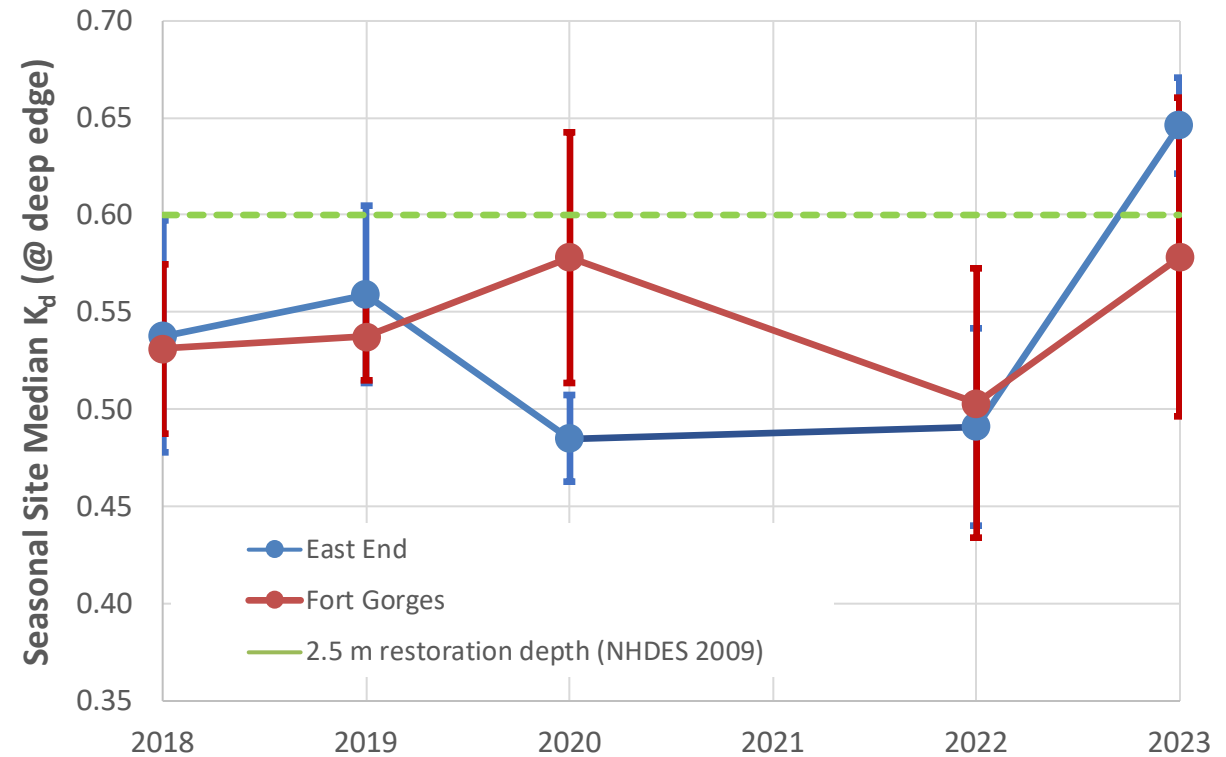
- Density (& percent cover & canopy height) decline along transects
- No flowering shoots in any quadrats during June monitoring
- Eelgrass patchy w/in beds off transects, most abundant along video transect at East End
- $K_d$  highly influenced by tide stage, generally conducive to eelgrass growth
- Continuous light & temperature monitoring stymied by lobster gear spatial conflicts
