SMALL POINT ROAD
(STATE ROUTE 216)
TIDAL CROSSING ASSESSMENT

PHIPPSBURG, MAINE

PRELIMINARY
DESIGN REPORT

ACADIA CIVIL WORKS
ENGINEERING DESIGN & CONSULTATION

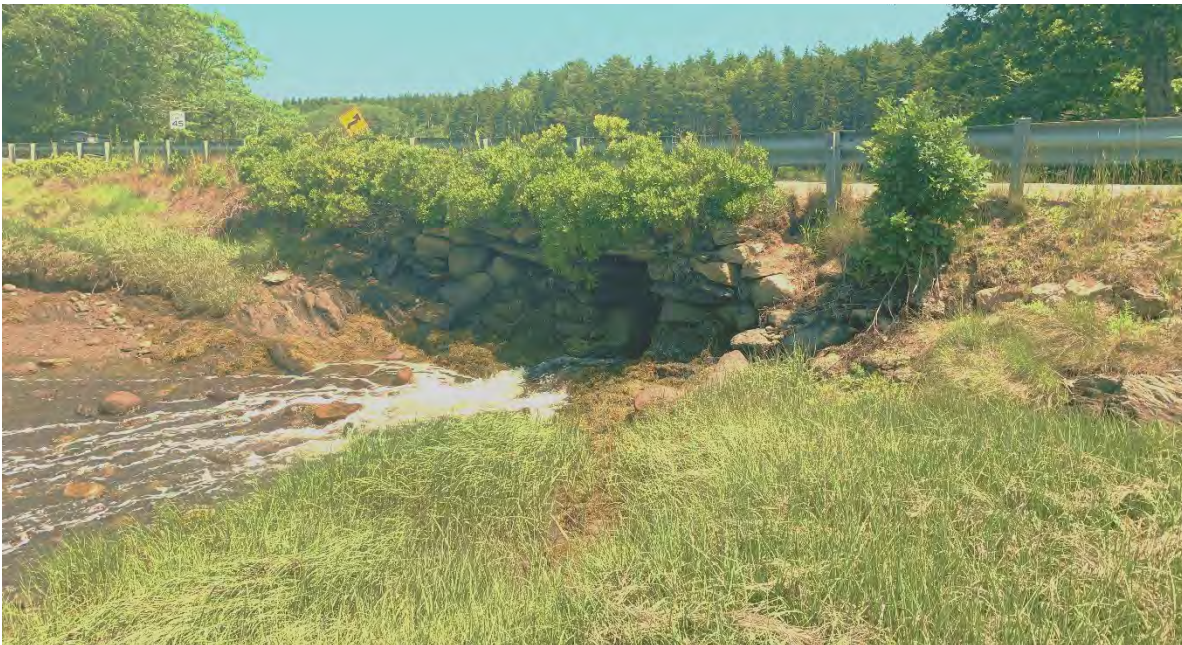
Primary Crossing of Small Point Road – Dry Laid Stone Culvert w/ approx. 2' Span

The primary culvert varies in width anywhere from approximately 30 inches to 24 inches along the length of the crossing. Its height is also variable with a nearly 3.5 feet dimension at the structure outlet and an approximate 18 inch to 24 inch height at the inlet. It appears that the dry laid stone walls bear directly on ledge and support a series of timber beams along the structure roof/deck. Many of the timber components are deteriorating. Additionally, substantial organic material has collected around the timber deck members, which further restricts flow within the structure

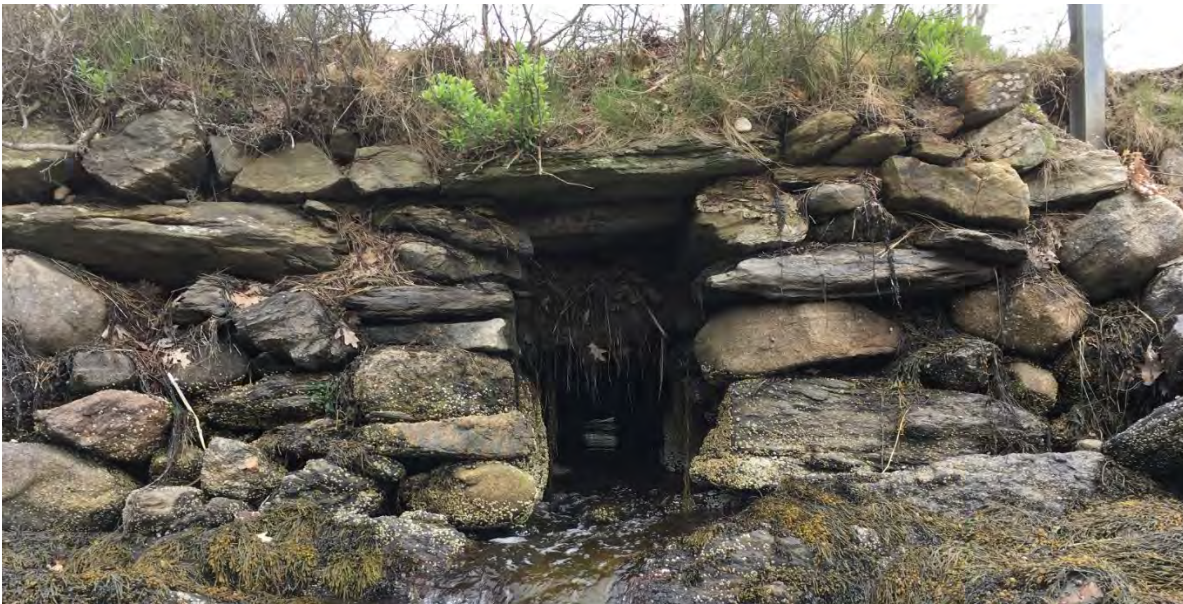
Primary Crossing of Small Point Road (outlet) - Dry Laid Stone Culvert w/ Timber Deck Beams

The primary crossing of Small Point Road is located within the influence of current mean tides. While the exchange of tidal waters is restricted by the structure, the stream and wetland system upstream of the crossing is also tidally influenced. The primary crossing is founded directly on ledge (bedrock), which forms a grade control along the structure's invert at its outlet. The inlet of the structure is also founded on ledge, but the invert has been plugged by some additional loose rock. The ledge grade control, combined with the horizontal restriction of the structure has resulted in a persistent pool at low tides just upstream of the roadway.

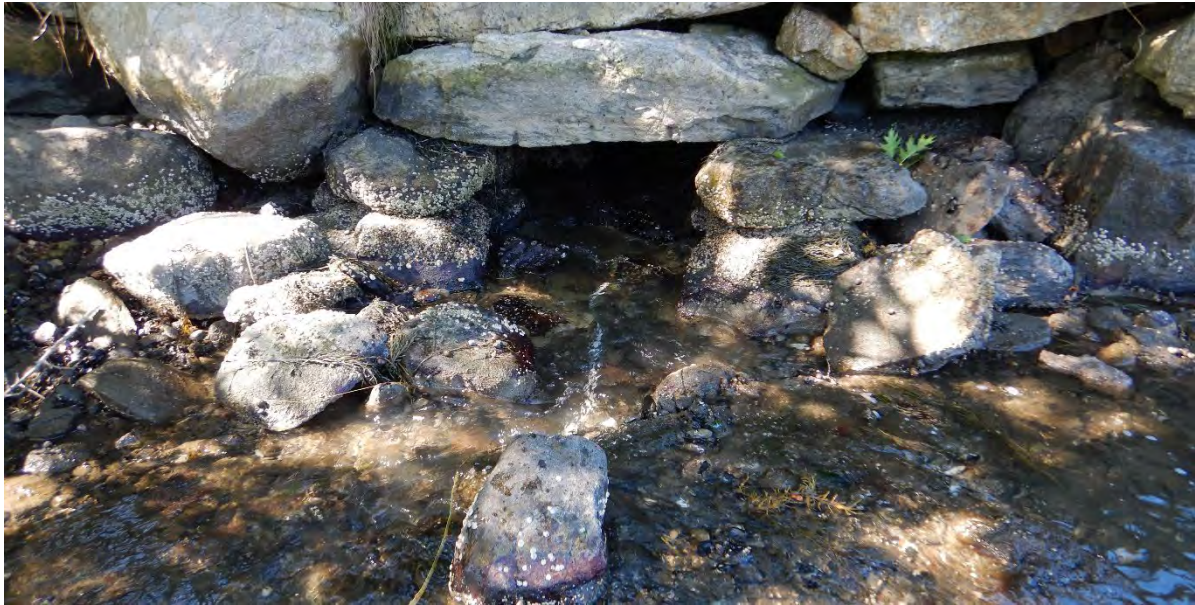
Primary Crossing of Small Point Road (inlet) - Dry Laid Stone Culvert w/ Timber Deck Beams

The Maine DOT has recently inspected the structure as it is located along State Route 216. As identified by the Maine DOT, the “deck of this culvert is timber frame. The walls and base are granite stone. The timber is in very poor condition with many timber pieces missing. Displaced blocks and wall deformation.” Overall, the Maine DOT indicates that this structure is in “Poor” condition.

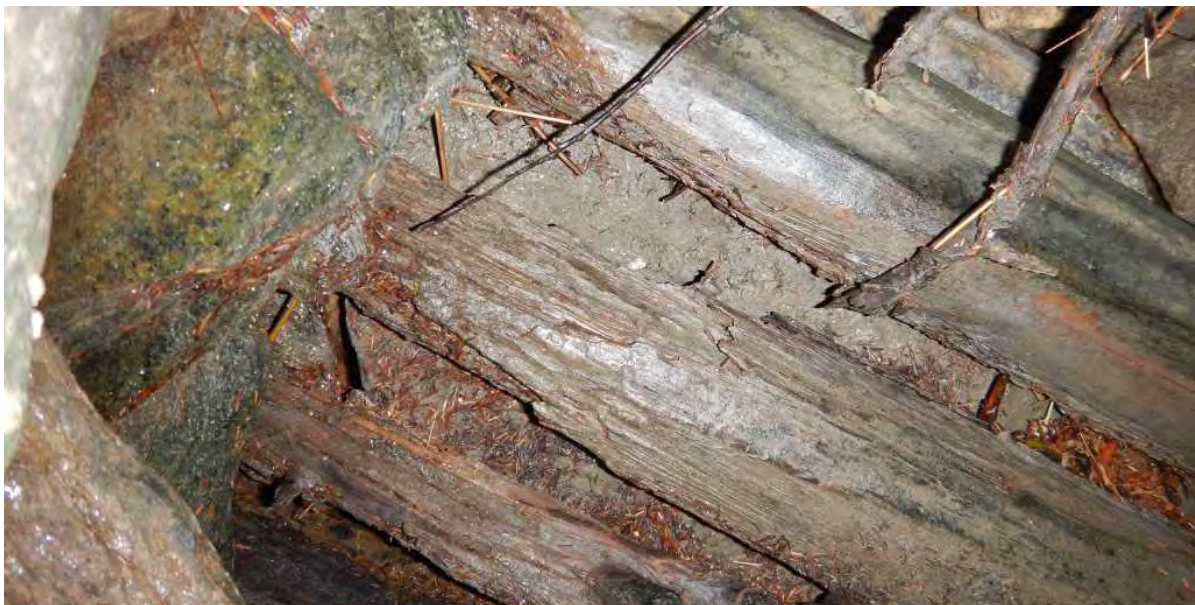
Primary Crossing of Small Point Road - Interior view of Deteriorated Timber Deck

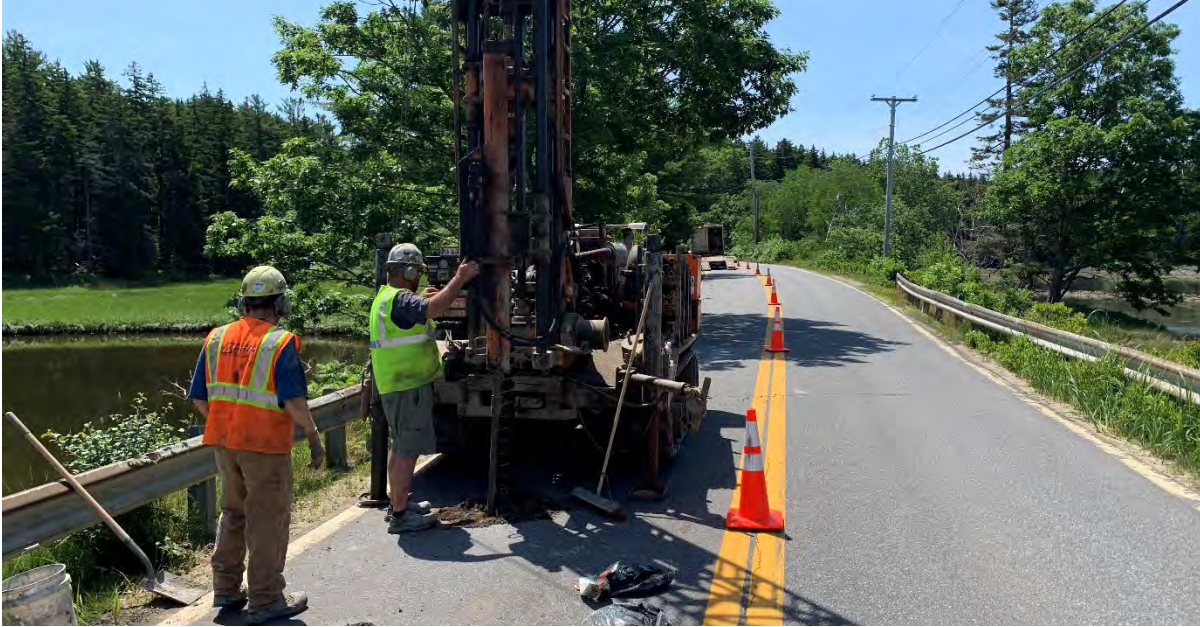
Boring/Probe Explorations being Performed on Small Point Road in July 2020

Acadia Civil Works worked with Northern Test Boring, Inc. to explore subsurface conditions along Small Point Road in the vicinity of the primary crossing infrastructure. The primary goal of the explorations was to probe the roadway in various locations to determine the depth of the underlying ledge surface. In addition to the probes several split spoon samples were also recovered to characterize the underlying material. Associated field work was performed in July of 2020. The specific location of the probes, as well as the associated ledge elevations have been shown on the map included as Appendix C.

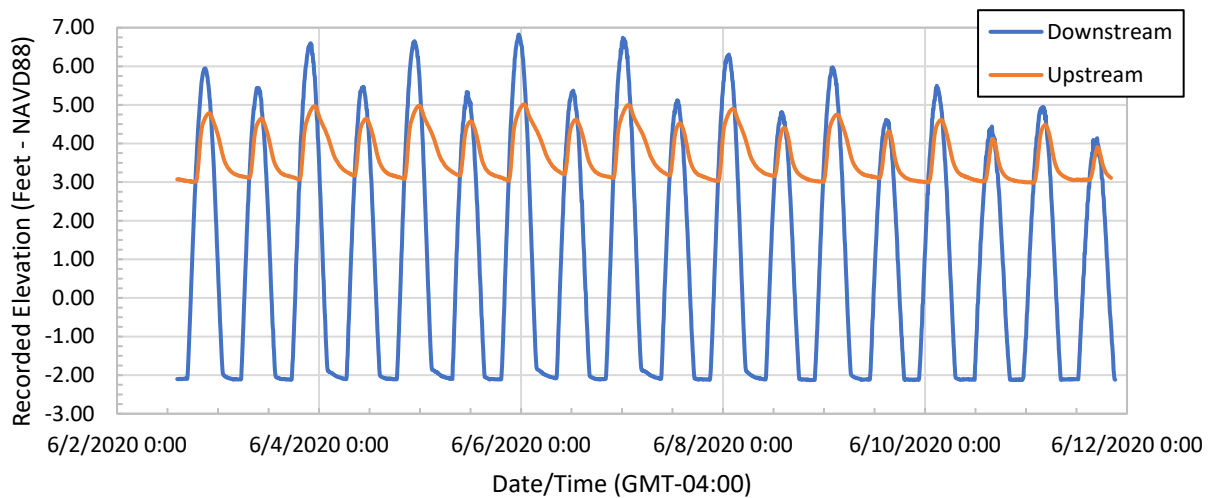
Figure 9 – Recorded Water Surface Elevations at Small Point Road

As shown in Figure 9, there is substantial difference between upstream and downstream tidal elevations at the primary crossing of Small Point Road. This is most pronounced at the lower end of the tide cycle when upstream elevations are “hung” by the culvert crossing and the upstream area is impounded at higher elevations. However, the higher end of the tide cycle is also affected, as the downstream water surface reaches higher elevations than the upstream areas.

It should be noted that the downstream water level logger was occasionally exposed to air at low-tide. This occurred when tide levels dropped below elevation -2 feet.

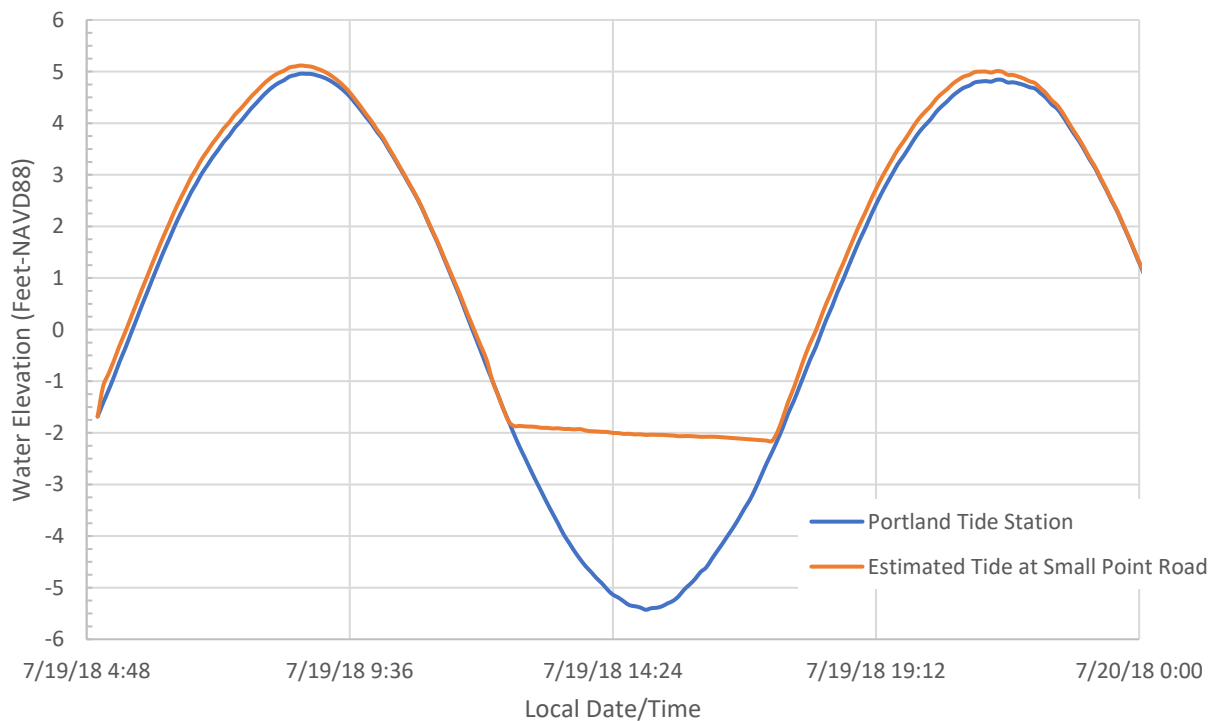
Figure 12 - Estimated Mean Higher-High Tide Conditions at Small Point Road

NOAA reports that the Mean High Water (MHW) and Mean Higher-High Water (MHHW) elevations (2018-Figure 14) are 4.40 and 4.82 feet (NAVD88), respectively. Based upon a review of the data recorded at the Portland Tide Gauge for 2018, there was an event that occurred on July 19, 2018 which was quite similar to the reported MHHW elevation and was not influenced by any significant weather event. Using the July 19th data as a proxy for mean higher-high tidal condition, the curve shown in Figure 11 was applied to the Portland Tide Data to develop the approximated MHHW conditions downstream of the Small Point Road Crossing. Figure 12 depicts the estimated MHHW conditions downstream of Small Point Road and is overlain on the Portland Tide Station data for July 19, 2018.

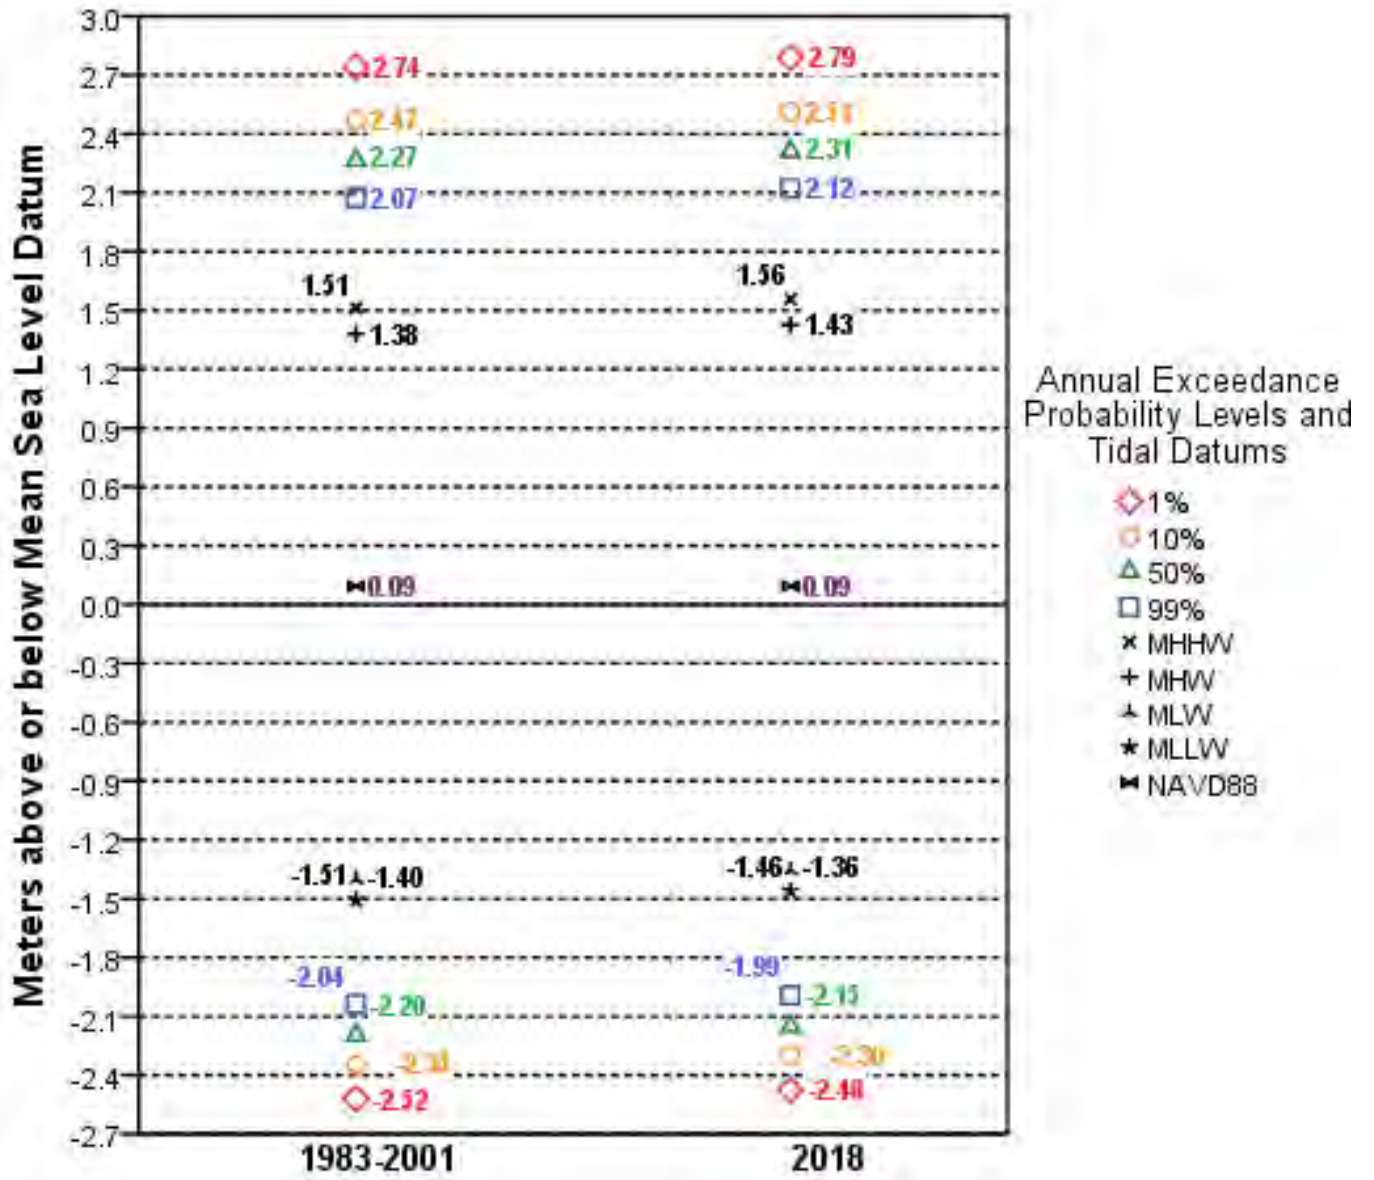
Figure 14 - NOAA Portland Tide Station (8418150)

During large storms or other extreme conditions, tides will reach higher elevations than the HAT. NOAA has published the following data (See Figure 14) related to annual exceedance probability levels at the Portland Tide Gauge (ID# 8418150).

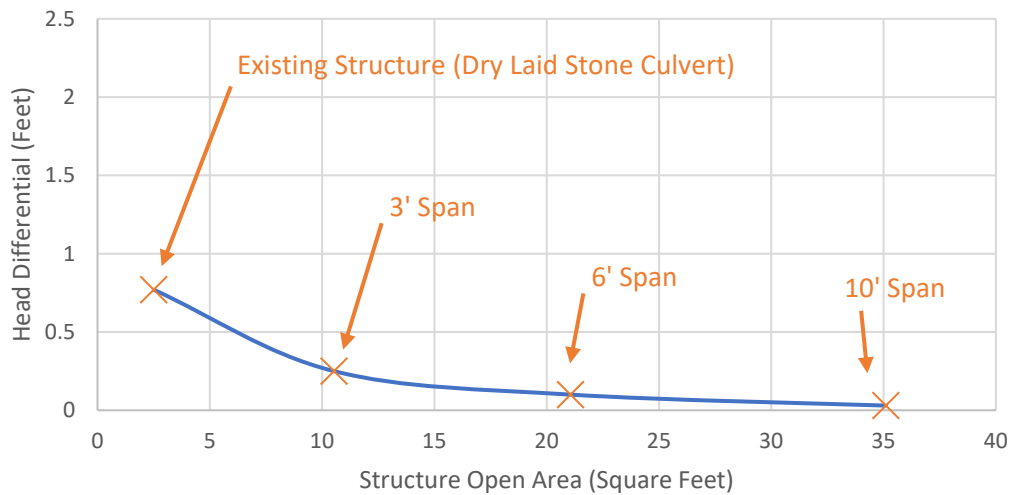
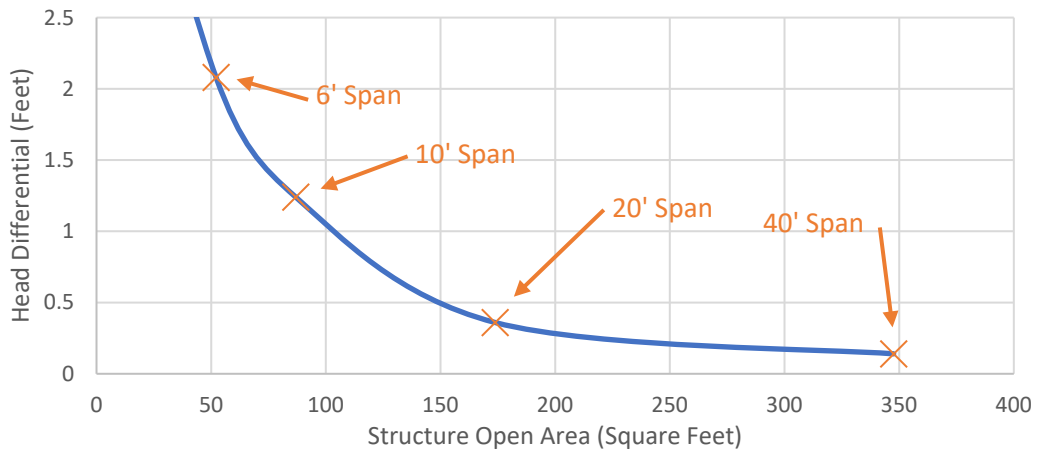
Figure 19 –MHHW (2018) Sizing Curve at Small Point Road (Primary)

Figure 20 – 99% Exceedance Tide (2018) Sizing Curve at Small Point Road (Primary)

Figure 21 - Future MHHW (2100-Int) Sizing Curve at Small Point Road (Primary)

Figure 22 - Future 99% Exceedance Tide (2100-Int) Sizing Curve at Small Point Road (Primary)

Figure 23 - Future MHHW (2100-High) Sizing Curve at Small Point Road (Primary)

Figure 24 - Future 99% Exceedance Tide (2100-High) Sizing Curve at Small Point Road (Primary)

The proposed model was used to evaluate a range of proposed crossing infrastructure sizes at Small Point Road. The peak instantaneous head differential of the simulated tide surfaces (downstream subtracted from upstream) was recorded and plotted on a graph to generate a curve of the tide differential versus structure open area. This curve is intended to be used as a tool for decisions related sizing of the proposed crossing infrastructure. A separate curve was developed for each evaluated hydrologic condition.

Through discussion with the Project Team the NOAA 99% Annual Exceedance (1-year) tide and the Mean Higher-High Water (MHHW) published by NOAA were utilized as the design hydrologic conditions. The MHHW represents an average of the highest daily high tide. While the 99% exceedance tide is higher than average, it is essentially the 1-year tide, which has a statistical 99% chance of occurring in each calendar year. Sizing curves for each of these tidal conditions, as well as the conditions modified by future sea level rise was evaluated. The sizing curve for each of these hydrologic conditions is shown below as Figures 19 through 24.

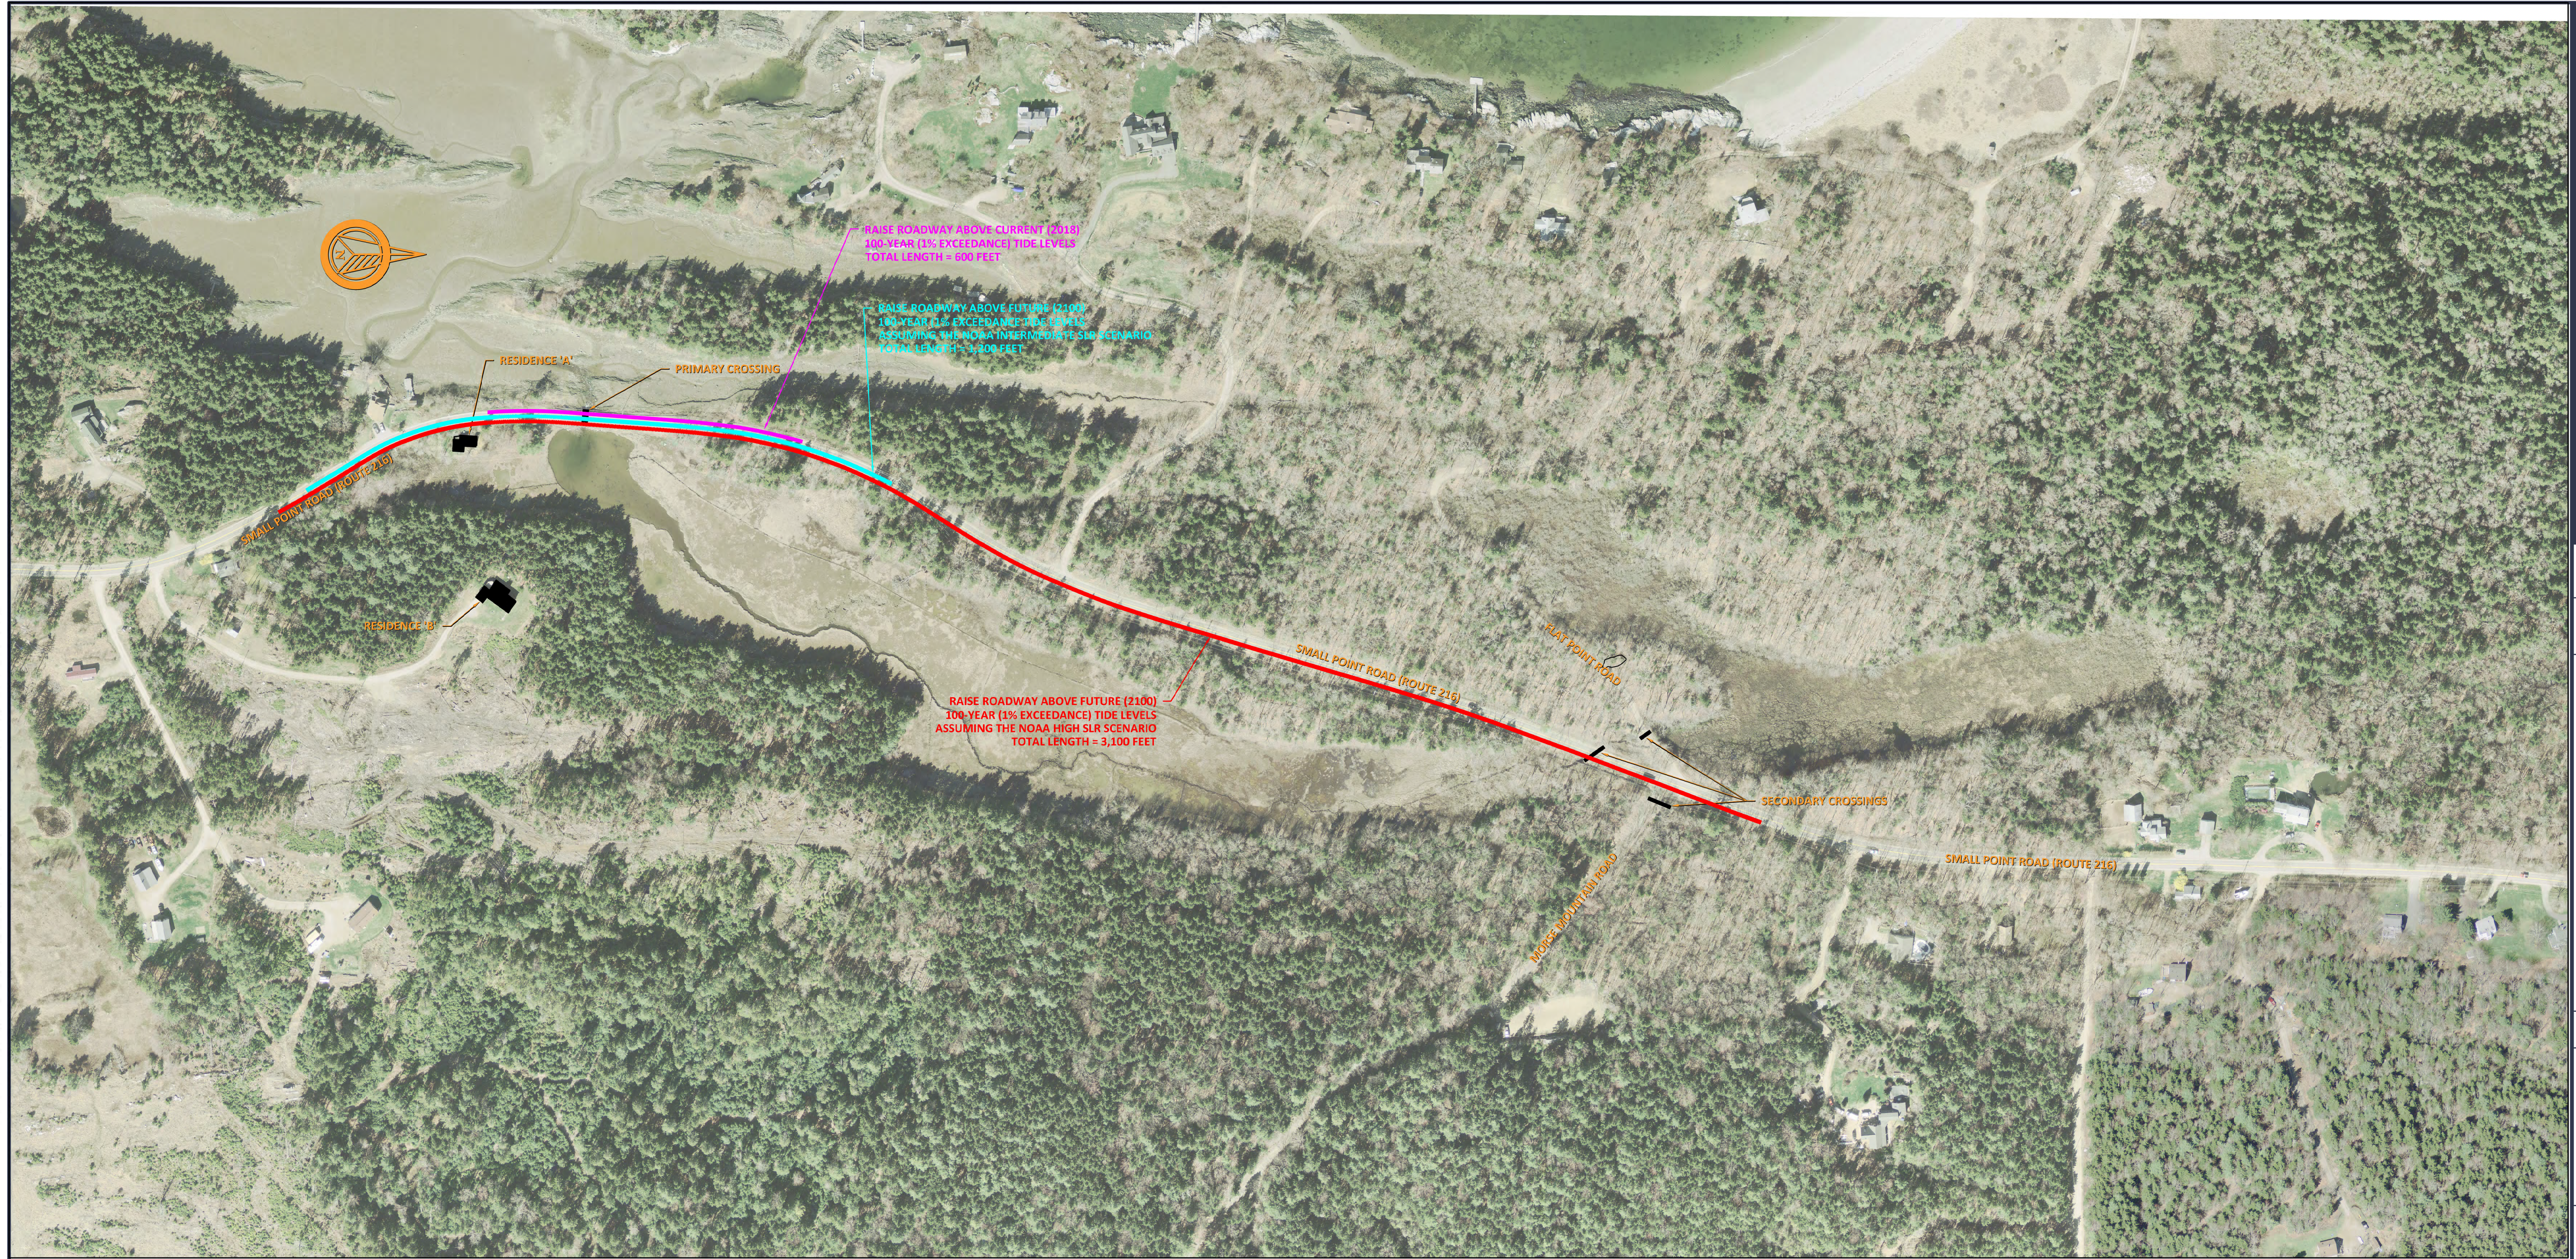
SMALL POINT ROAD STRUCTURE
TIDAL STREAM CROSSING ASSESSMENT
PHIPPSBURG, ME
TOWN OF PHIPPSBURG
ROADWAY EXTENTS MAP
JAN 2021

- RAISE ROADWAY ABOVE CURRENT (2018) 100-YEAR (1% EXCEEDANCE) TIDE LEVELS
TOTAL LENGTH OF ROADWAY RECONSTRUCTION = APPROXIMATELY 600 LINEAR FEET
- RAISE ROADWAY ABOVE FUTURE (2100) 100-YEAR (1% EXCEEDANCE) TIDE LEVELS
ASSUMING A NOAA-2017 INTERMEDIATE SEA LEVEL RISE SCENARIO
TOTAL LENGTH OF ROADWAY RECONSTRUCTION = APPROXIMATELY 1,200 LINEAR FEET
- RAISE ROADWAY ABOVE FUTURE (2100) 100-YEAR (1% EXCEEDANCE) TIDE LEVELS
ASSUMING A NOAA-2017 HIGH SEA LEVEL RISE SCENARIO
TOTAL LENGTH OF ROADWAY RECONSTRUCTION = APPROXIMATELY 3,100 LINEAR FEET
